Column Tests

Column Specifications and Design

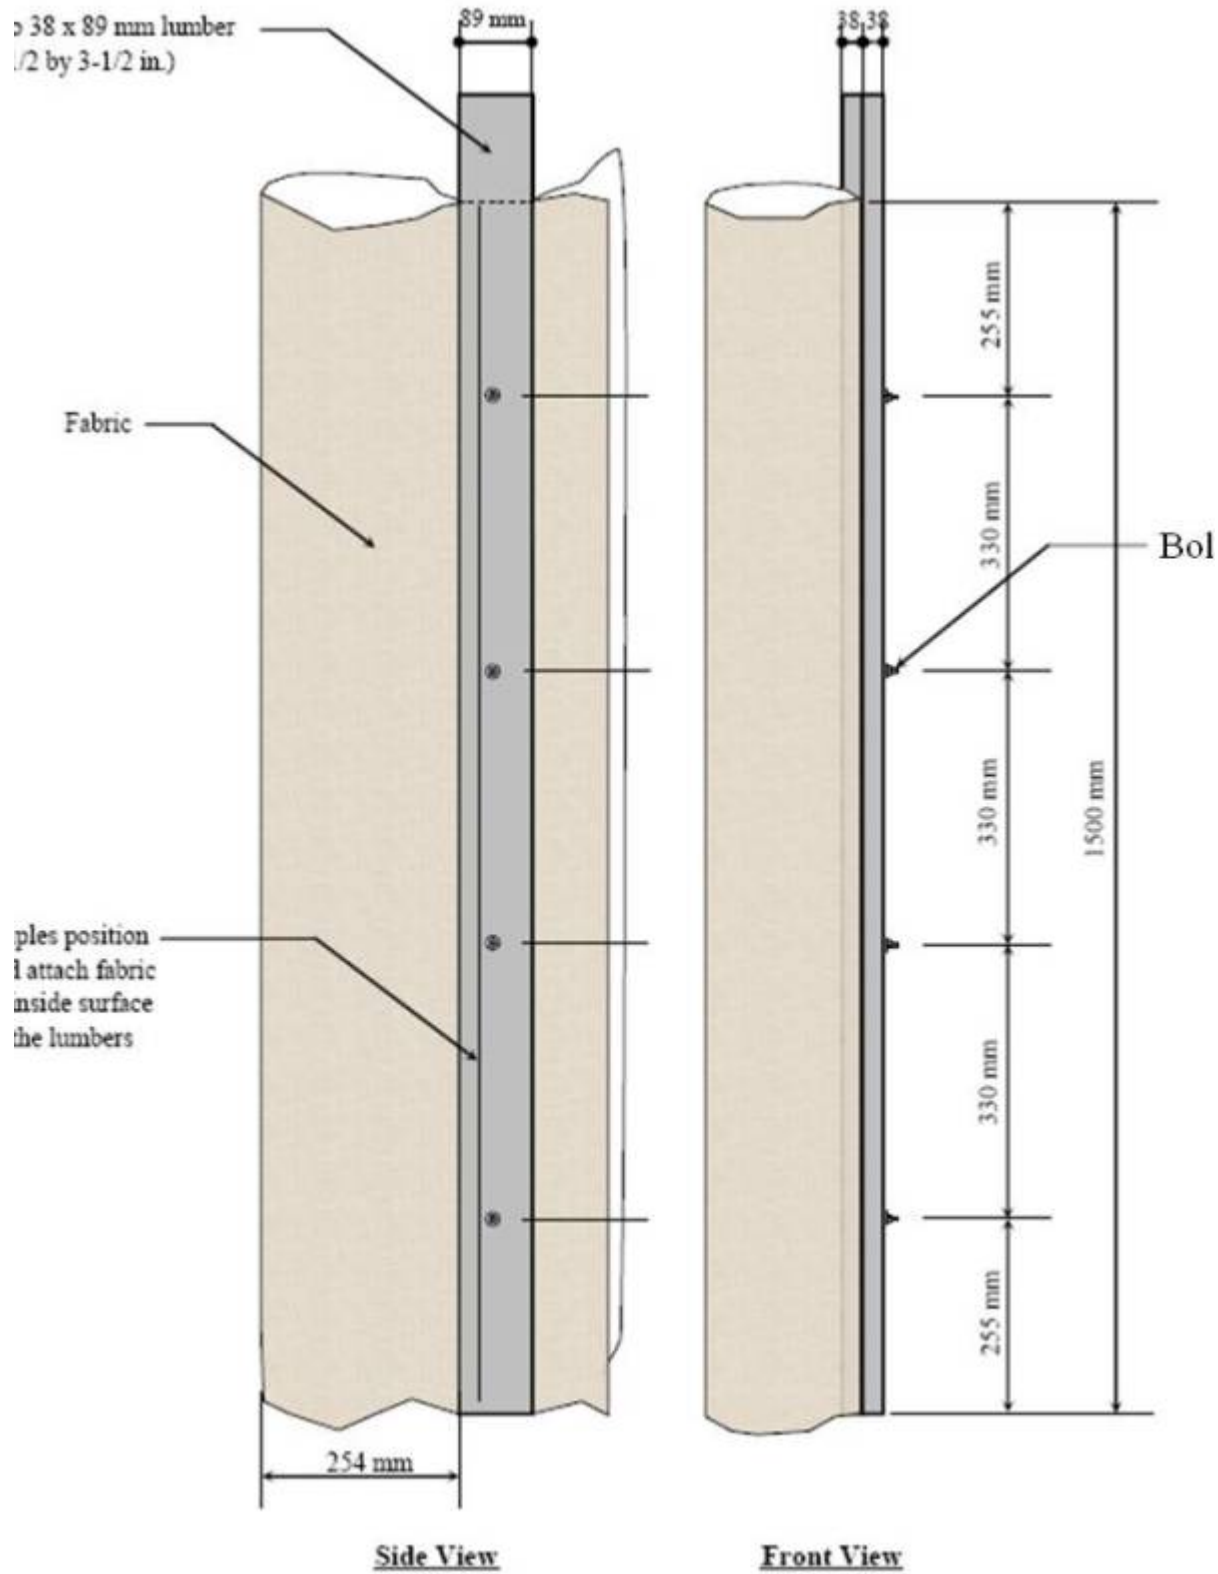
batch. The columns were cast using normal concrete and flyash concrete. Total of 6 columns were cast. As shown in Figure 43, the formwork was essentially the same as that used to cast the earlier cylinder specimens. The formwork was made of a single, rectangular, piece of fabric sandwiched between two vertical pieces of 38 x 89 mm lumber (2" by 4"). The fabric was first fitted to create the proper diameter and stapled to the lumber pieces.

Figure 43: Configuration of the fabric formwork for reinforced concrete column.

from each other (though less staples would be probably also sufficient), providing a stitch line from top to bottom of the formwork. Orientation of the stitch line can be seen in Figure 43. Stapling provided an even distribution of the hoop forces along the height of the formwork and resulted in a uniform cylindrical geometry. The variation in diameter of the column along its length was dramatically reduced as demonstrated in Figure 68.

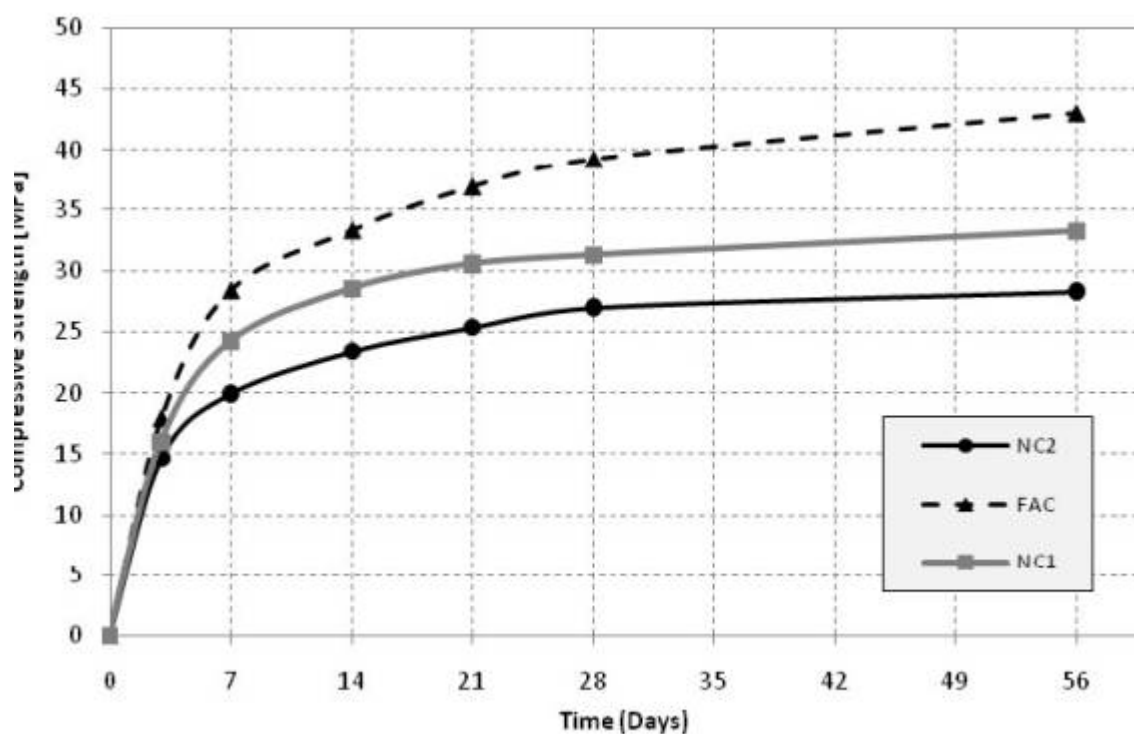
A compression testing machine was used to test the companion 101 by 203 mm (4 by 8 in.) concrete cylinders at the ages of 3, 7, 14, 28 and 56 days. All cured columns and the concrete cylinders were taken out of their molds simultaneously and were kept in the laboratory till testing. Figure 49 provides the data concluded from the cylinder compression tests. Both batches were specified to reach compressive strength of 25 MPa at 28 days but as the results show, the flyash concrete gained more compressive strength compared to the normal concrete. As seen in Figure 49, average compressive strength of the flyash sample at 28 days was measured as 39.2 MPa while the normal concrete specimens had average compression strength of 27 and 28.30 MPa. The actual compressive strength in both concretes was used to estimate the actual maximum axial load capacity of the columns.

Figure 49: Concrete strength gain with time.

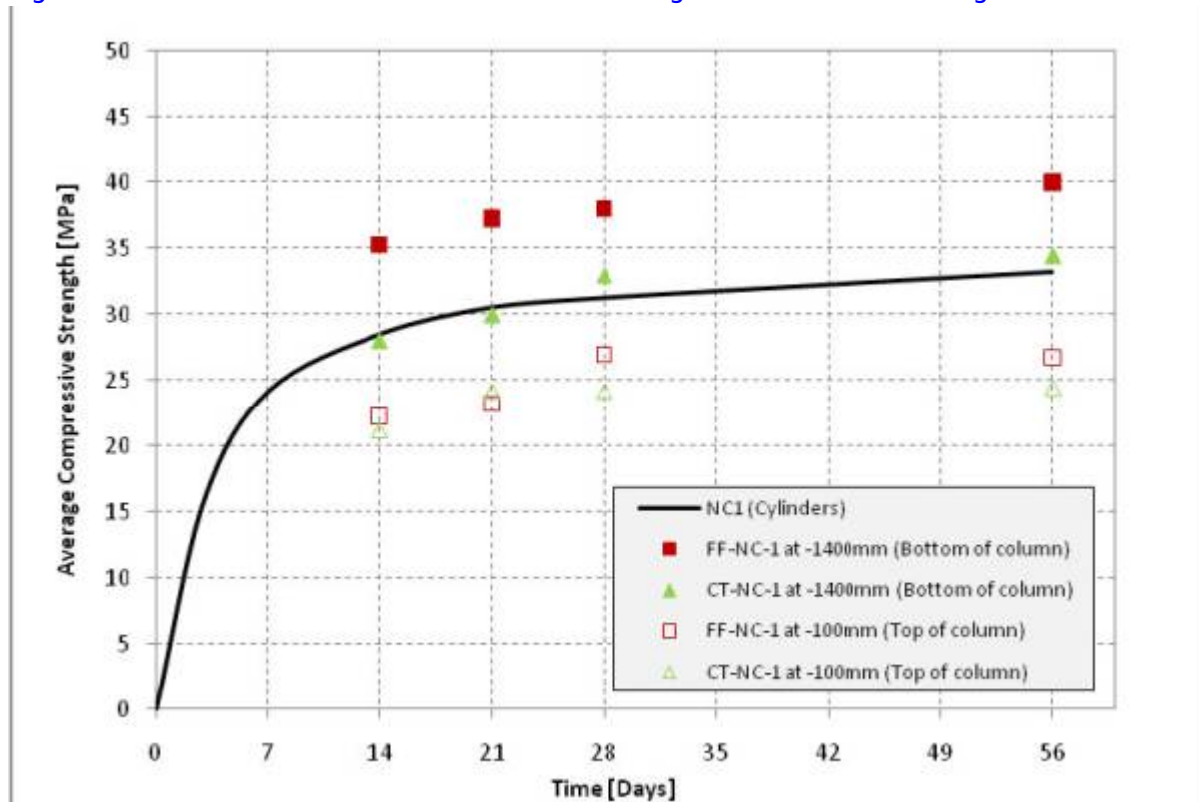
Compression strength test results from Schmidt hammer test have been compared to those from cylinder test for both normal and flyash concrete. As seen in Figures 51, 52 and 53, there are some fluctuations between the results obtained from Schmidt hammer and the PVC formed cylinders. The filled markers in the graph represent the bottom of the column, while the empty ones represent the top of the column.

As seen in Figure 51, compared to results from cylinder tests fabric formed column has gained an average of 21.8% extra strength at the bottom of the column while the bottom of the cardboard formed column shows almost the same results as the cylinders. At the top of the column, both cardboard and fabric formed columns showed an average of 28% less strength compared to the cylinder test results. As seen in Figure 52, cylinder test results for flyash concrete show more compressive strength than both top and bottom readings of the Schmidt hammer.

Figure 51: Normal concrete cylinders compared to Schmidt hammer results (Columns...

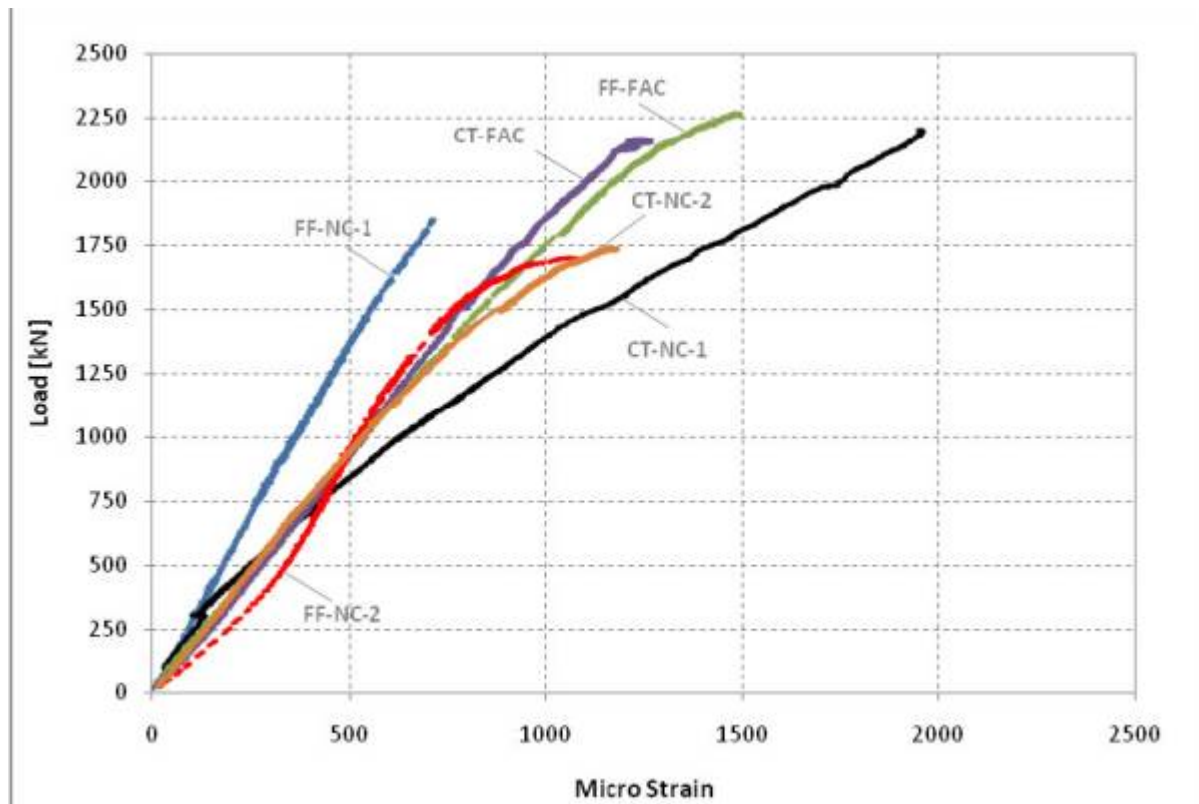
Figure 56 to 59 depict the strains in the middle, while Figures 60 to 63 depict the strains at the top of the column. Each figure represents one location either North, South, East or West and strains of that location in each column were plotted in the same graph for comparison.

Figure 56: Readings from North pi-gauges at the middle of all columns.

Figure 57: Readings from South pi-gauges at the middle of all columns.

Figure 58: Readings from East pi-gauges at the middle of all columns.

Figure 59: Readings from West pi-gauges at the middle of all columns.

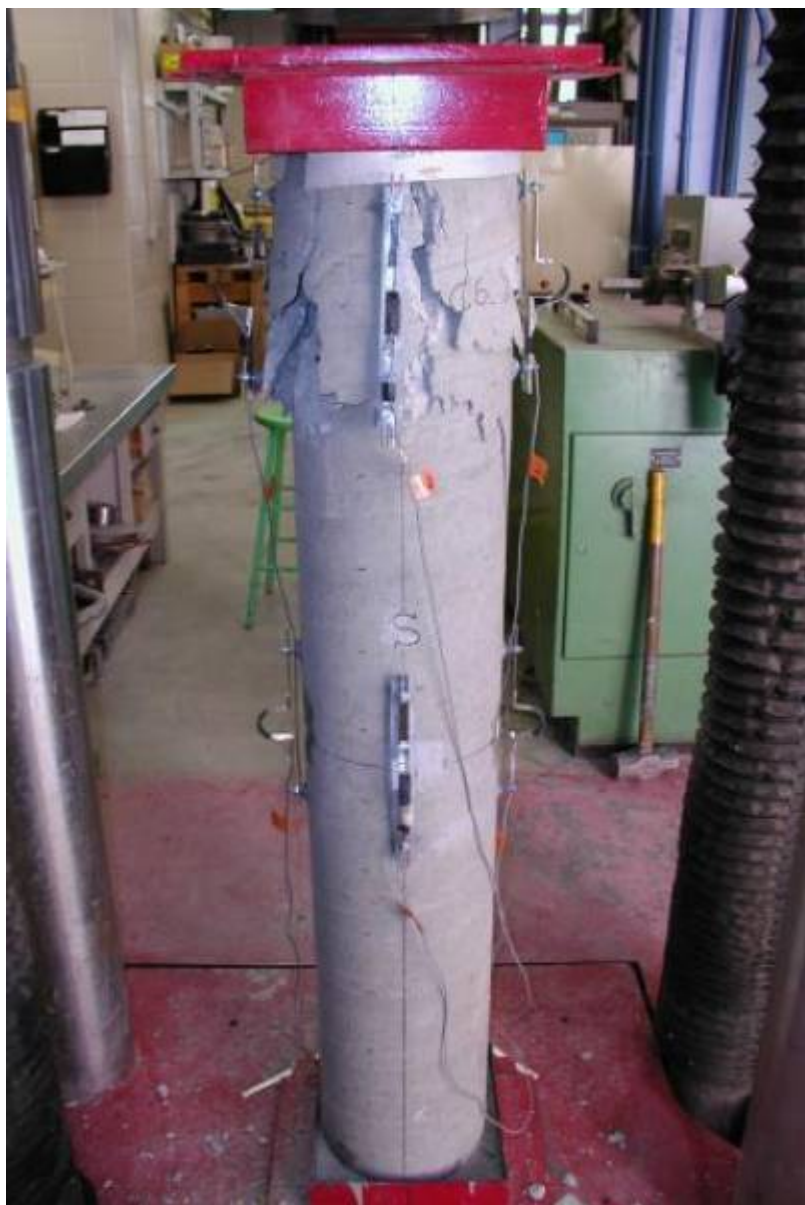
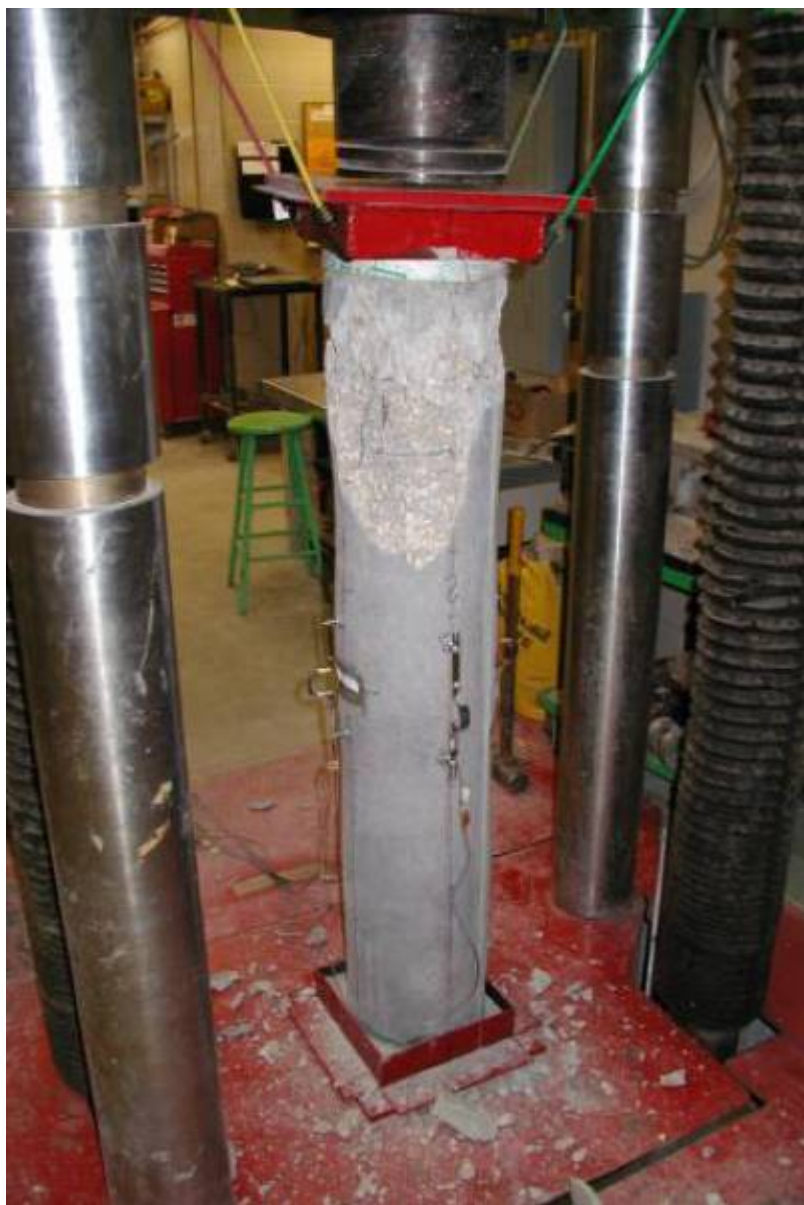
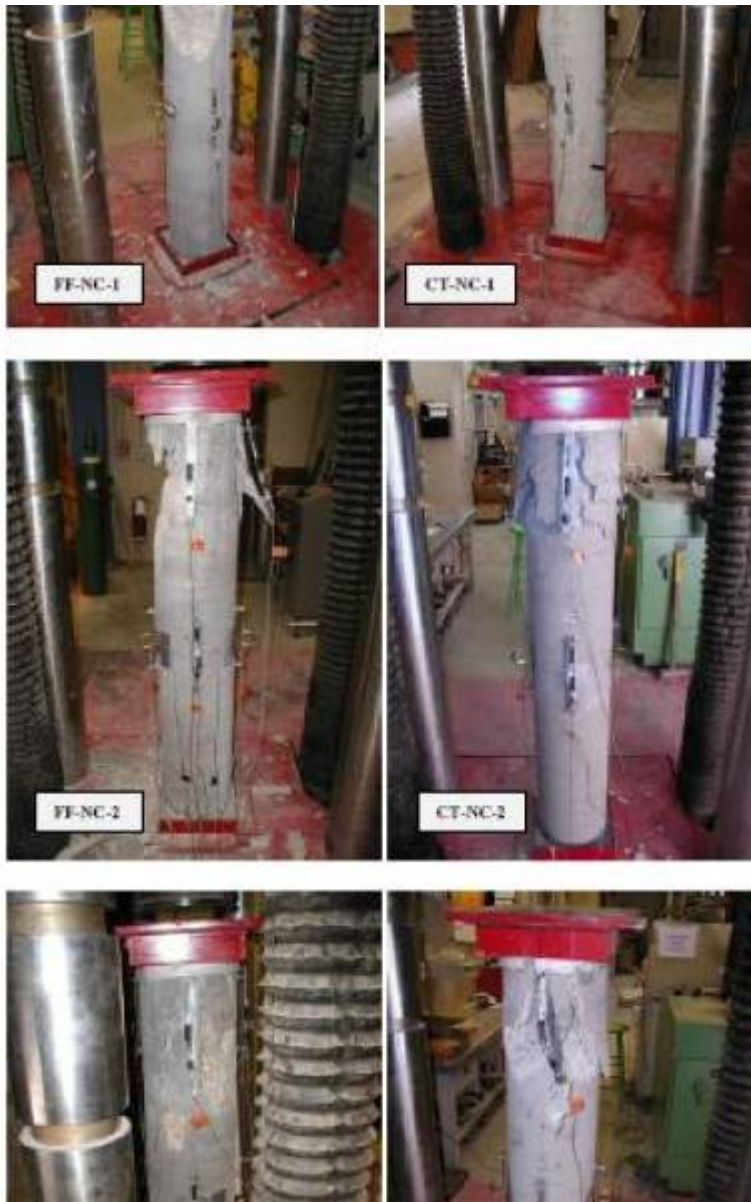
In order to be able to better observe behaviour and the failure pattern of the columns, all tests were videotaped. The failure pattern of the columns was a factor to be investigated in this phase of the study. Based on observations of the two cardboard and two fabric-formed column tested, the failure of the cardboard formed column started with crushing on top and then spalling till failure. Cardboard-formed columns presented a typical gradual failure with no sign of brittleness, no longitudinal cracks and no flaking. On the other hand, fabric-formed columns started with crushing on top and development of longitudinal cracks at the same time along with spalling. Also, some flaking and relative sudden failure of

outside surface was observed. Photographs of these column failures are shown in Figure 65 (page 82).

Figure 64: Column FF-NC-2 after failure.

Figure 65: Column CT-FAC after failure.

Figure 65: Column CT-NC-1 after failure.

Figure 65: Column CT-NC-2 after failure.

Figure 65: Column FF-FAC after failure.

Figure 65: Column FF-NC-1 after failure.

Figure 65: Column FT-NC-2 after failure.

Figure 65: All columns after failure.

Flaking and surface concrete delamination observed in the failure of both fabric-formed columns also confirms that the surface of the concrete cast in fabric formwork was more brittle than concrete cast in conventional formwork. The change in Poisson's ratio was also studied when these columns were tested. The value was derived from dividing the average value of the data from two circumferential strain gauges placed at 180° apart from one another, by their corresponding axial pi-gauges. Both flyash and normal concrete fabric formed columns, proved to have lower Poisson's ratio value which is another indication of brittleness and less surface deformation in the fabric-formed specimens. It is necessary to mention that it is nearly impossible to form a perfectly straight column using handmade fabric column formwork, so very small values of eccentricity in loading condition may occur. Since small values of the eccentricity do not create large moment values at end portion of the columns, the effects of small eccentricities can be neglected [2].

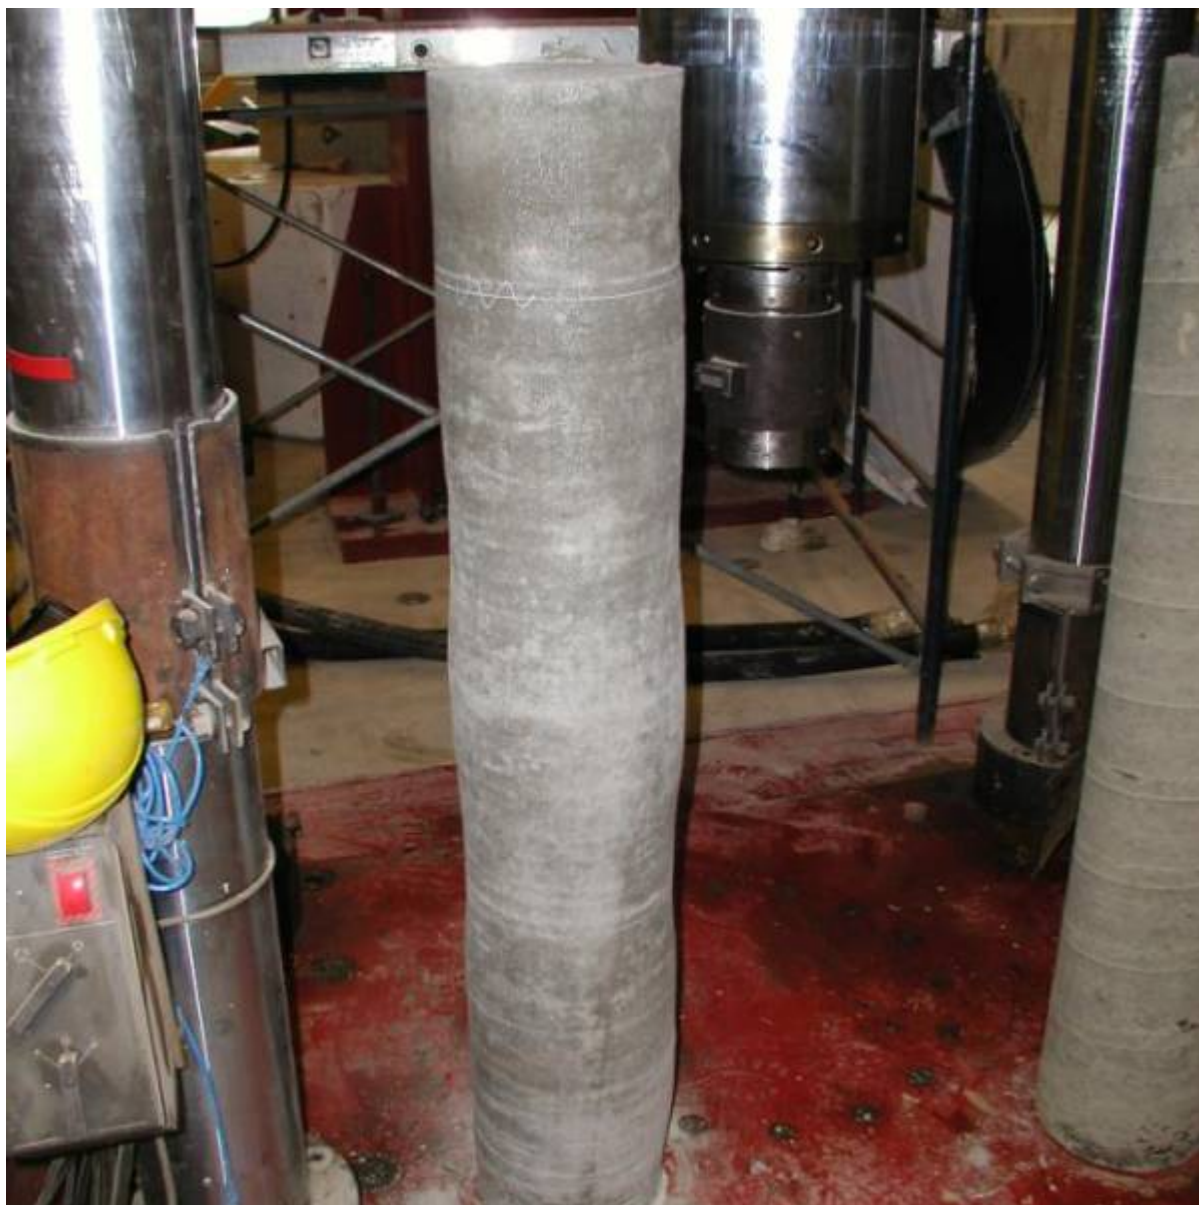
Our first attempt of casting a concrete column using fabric formwork was not quite successful. The column was bulgy at some points and it did not have constant diameter along its length while cardboard molds that are industrially manufactured are perfectly symmetrical tubes and form perfectly symmetrical columns. The reason for this problem was that the fabric was sandwiched between the boards using bolts and when the concrete was poured inside the mold, the hoop tension created by the liquid concrete pulled the fabric out between the bolts (Figure 66). Areas supported by bolts resisted the pressure while parts away from bolts deformed creating bulges along the length of the hardened concrete column, as shown in Figure 67.

Figure 67: Bulged concrete column.
