# Column Tests

In order to evaluate the effect of fabric formwork on structural behaviour of a column, full size fabric-formed and conventionally formed reinforced concrete columns were de-signed and tested to failure under concentric axial load. The variables in these tests were two types of formwork; permeable fabric versus cardboard and two types of concrete; Flyash concrete and normal concrete. The fabric of choice was Geotex 315ST due to its better surface finish.

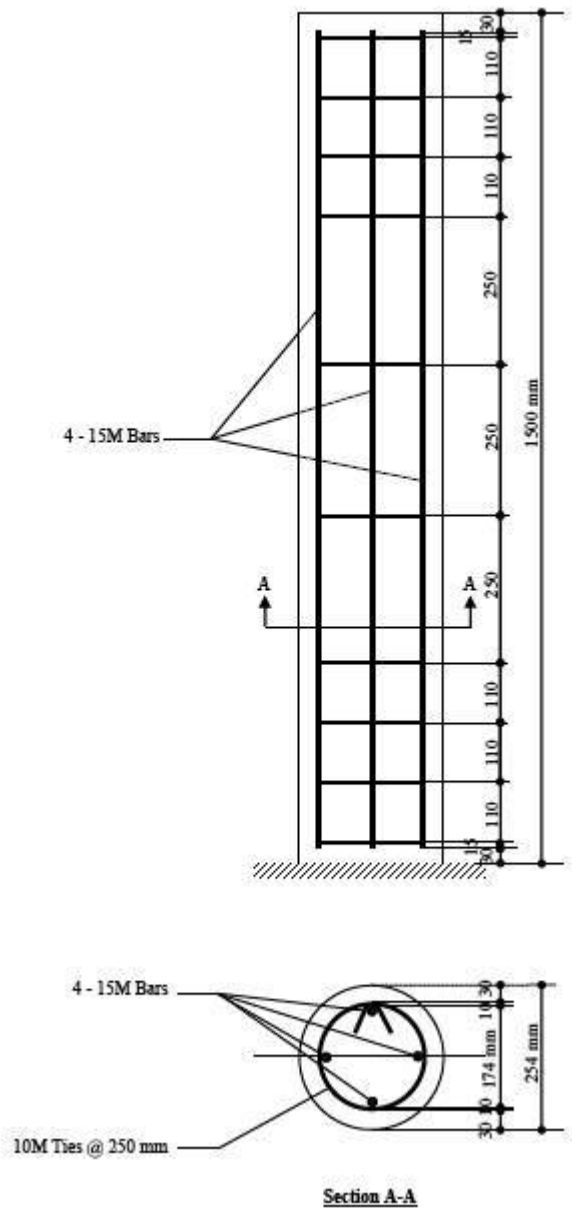
Figure 42: Column reinforcement details.

All columns had 254 mm radius and the column height was limited to 1500 mm. Based on calculations, four 15M bars were considered as the longitudinal bars, tie size was se-lected as 10M and tie spacing(s) was calculated as 250 mm (center to centre) and tie hooks, were set as 135 degrees. Arrangement and configuration of the reinforcement in the column has been shown in Figure 42.

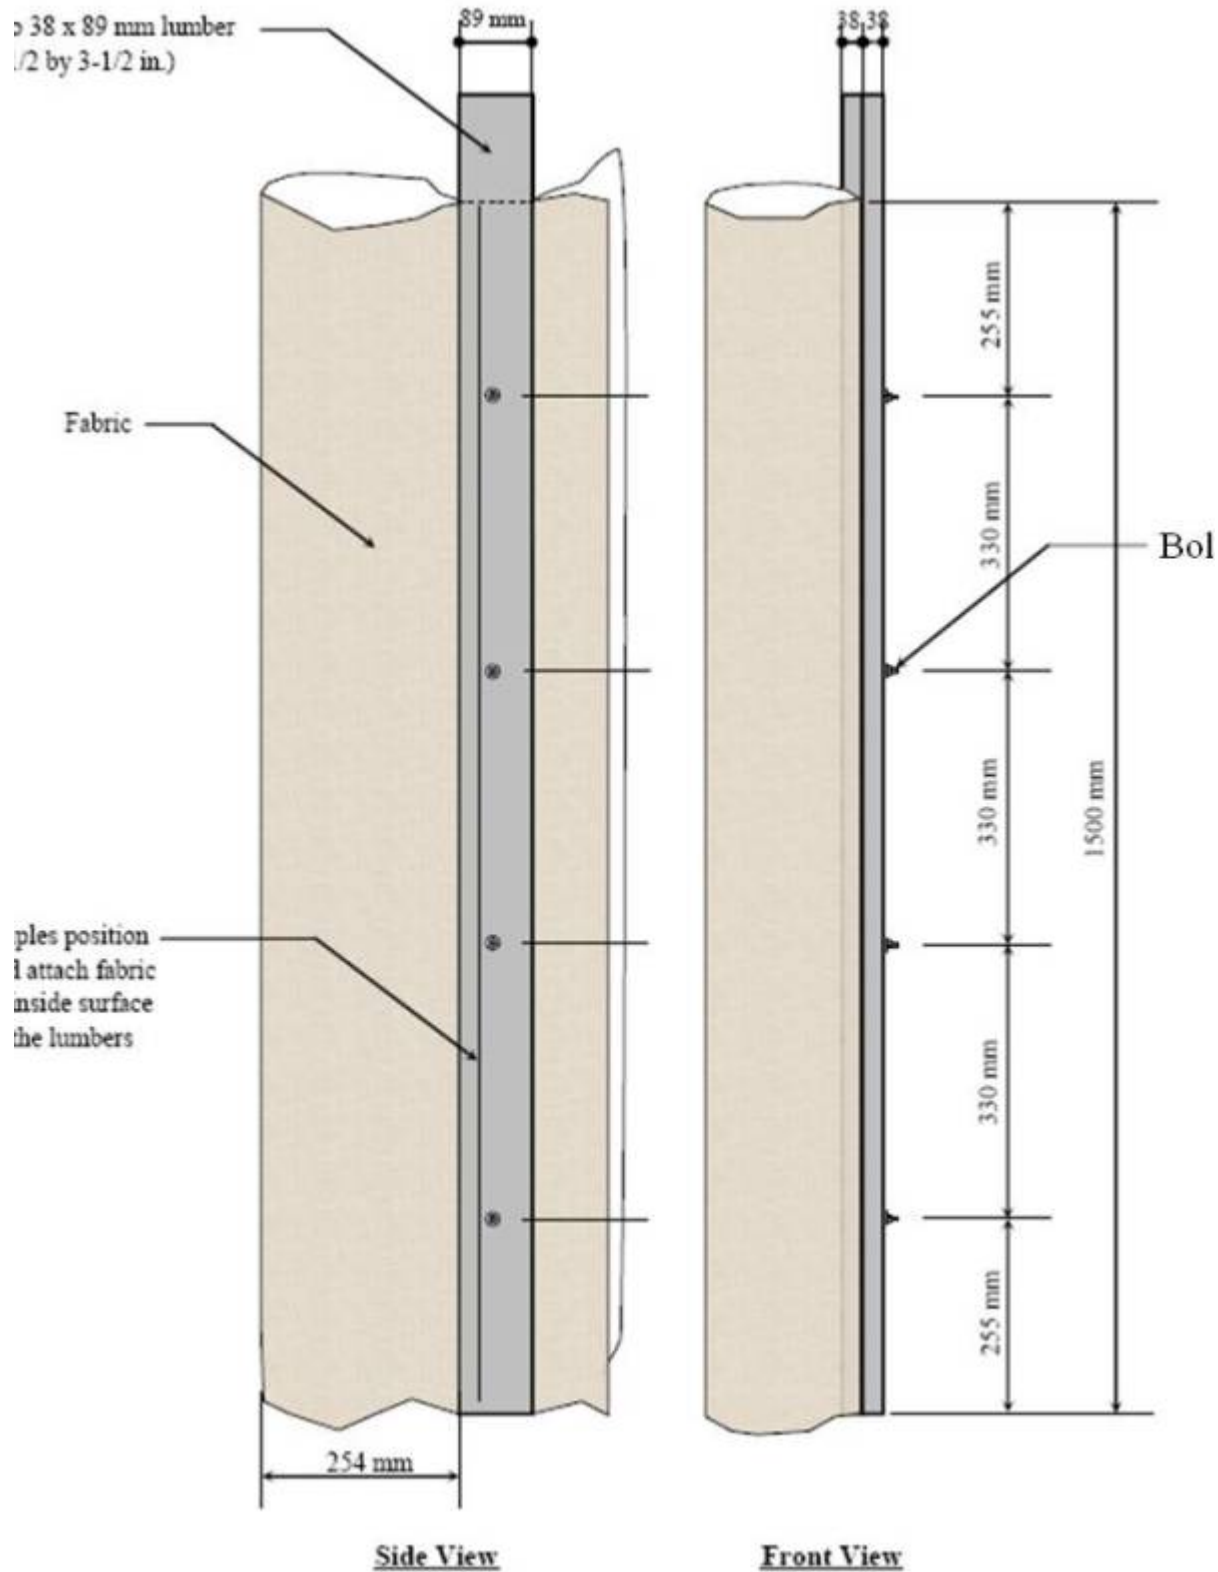
Figure 43: Configuration of the fabric formwork for reinforced concrete column.

batch. The columns were cast using normal concrete and flyash concrete. Total of 6 columns were cast. As shown in Figure 43, the formwork was essentially the same as that used to cast the earlier cylinder specimens. The formwork was made of a single, rectangular, piece of fabric sandwiched between two vertical pieces of 38 x 89 mm lumber (2" by 4"). The fabric was first fitted to create the proper diameter and stapled to the lumber pieces.

from each other (though less staples would be probably also sufficient), providing a stitch line from top to bottom of the formwork. Orientation of the stitch line can be seen in Figure 43. Stapling provided an even distribution of the hoop forces along the height of the formwork and resulted in a uniform cylindrical geometry. The variation in diameter of the column along its length was dramatically reduced as demonstrated in Figure 68.

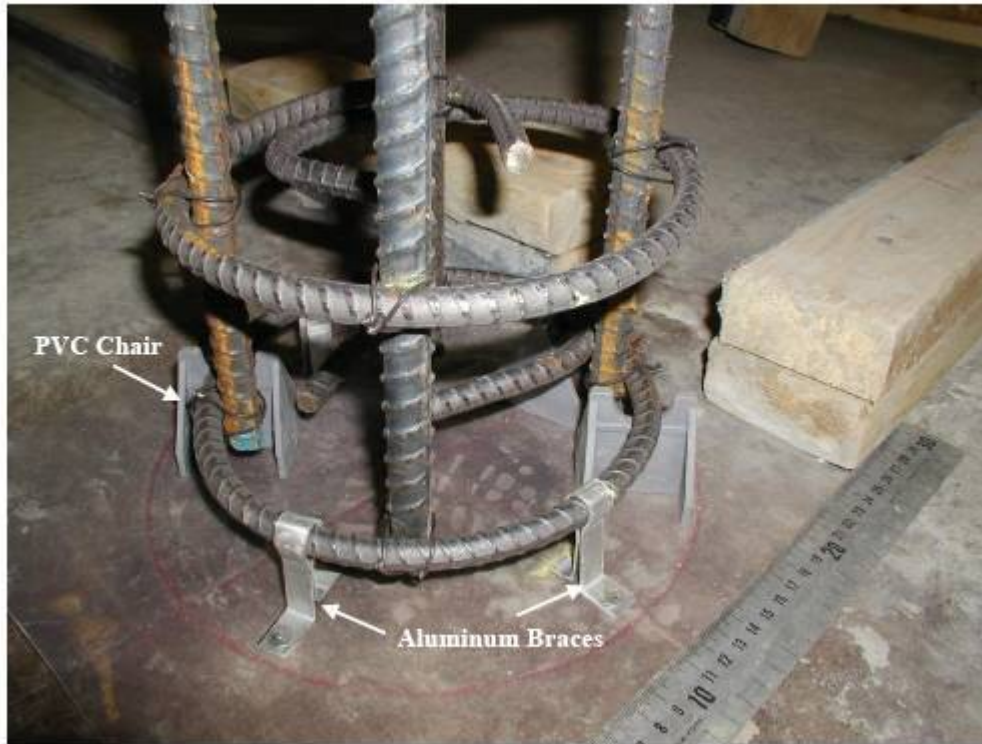
Figure 45: Details of the bottom of the column.

After that, the wooden pieces were bolted together in four locations along the length of the formwork to make the closure of the formwork as a cylindrical vessel. Figure 44 shows the finished formwork set up for both cardboard and fabric formworks. Both formworks were supported in a vertical position by diagonal braces in two directions for lateral support. Plastic spacers (PVC chairs) were installed beneath the reinforcement cages in order to create a 30 mm space between the longitudinal bars and ties and the bottom of the columns. The cages were centered and then fixed to the wood floor using handmade aluminum braces in order to avoid possible movements of the reinforcement cage during the casting as shown in Figure 45.

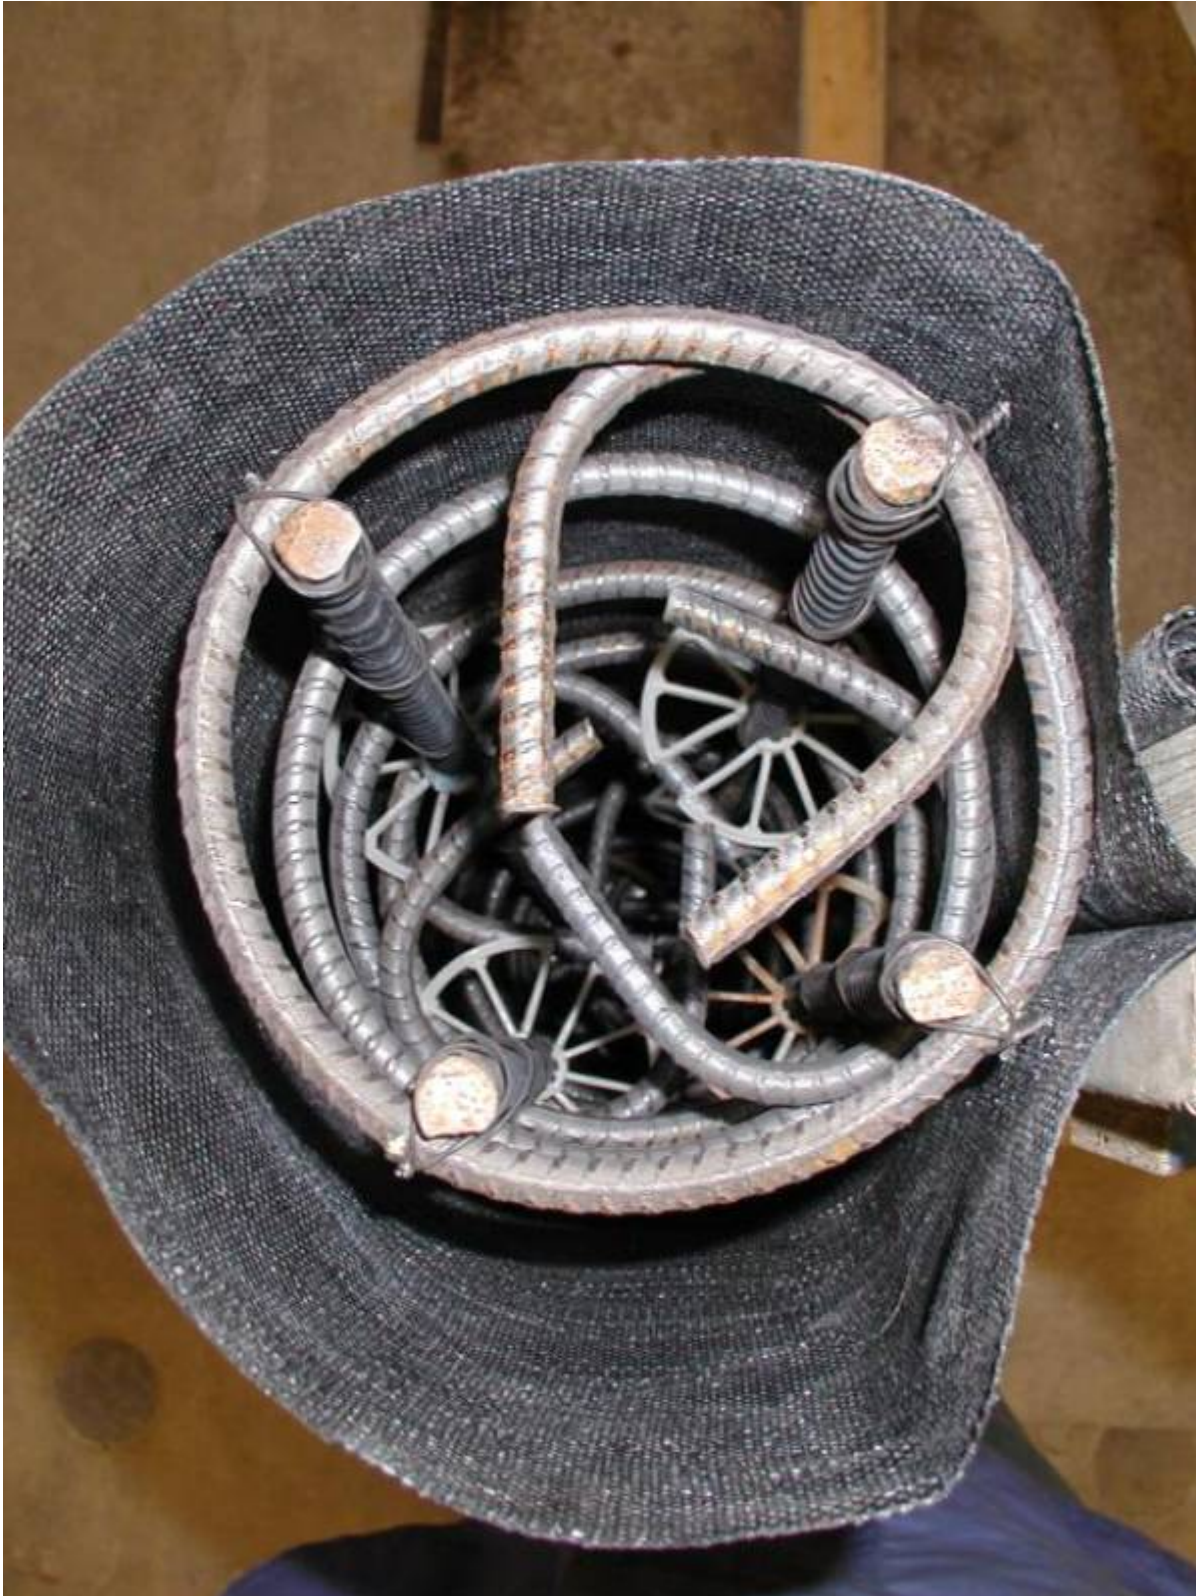
Figure 46: Reinforcement cage.

«fs medium>The cover distance between both fabric and cardboard formworks was maintained by using plastic wheel spacers on the longitudinal bars. These spacers were also used to keep the reinforcement cage in the centre of the formwork during casting as shown in Figure 46.</fs>

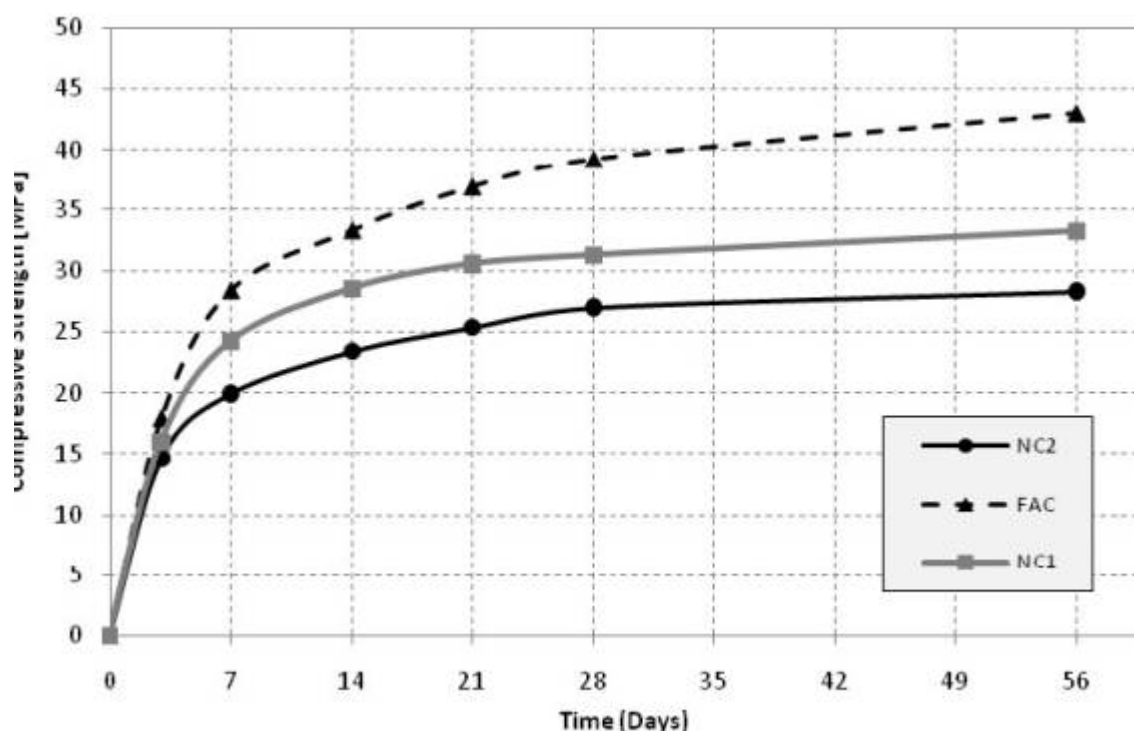
Figure 49: Concrete strength gain with time.

A compression testing machine was used to test the companion 101 by 203 mm (4 by 8 in.) concrete cylinders at the ages of 3, 7, 14, 28 and 56 days. All cured columns and the concrete cylinders were taken out of their molds simultaneously and were kept in the laboratory till testing. Figure 49 provides the data concluded from the cylinder compression tests. Both batches were specified to reach compressive strength of 25 MPa at 28 days but as the results show, the flyash concrete gained more compressive strength compared to the normal concrete. As seen in Figure 49, average compressive strength of the flyash sample at 28 days was measured as 39.2 MPa while the normal concrete specimens had average compression strength of 27 and 28.30 MPa. The actual compressive strength in both concretes was used to estimate the actual maximum axial load capacity of the columns.

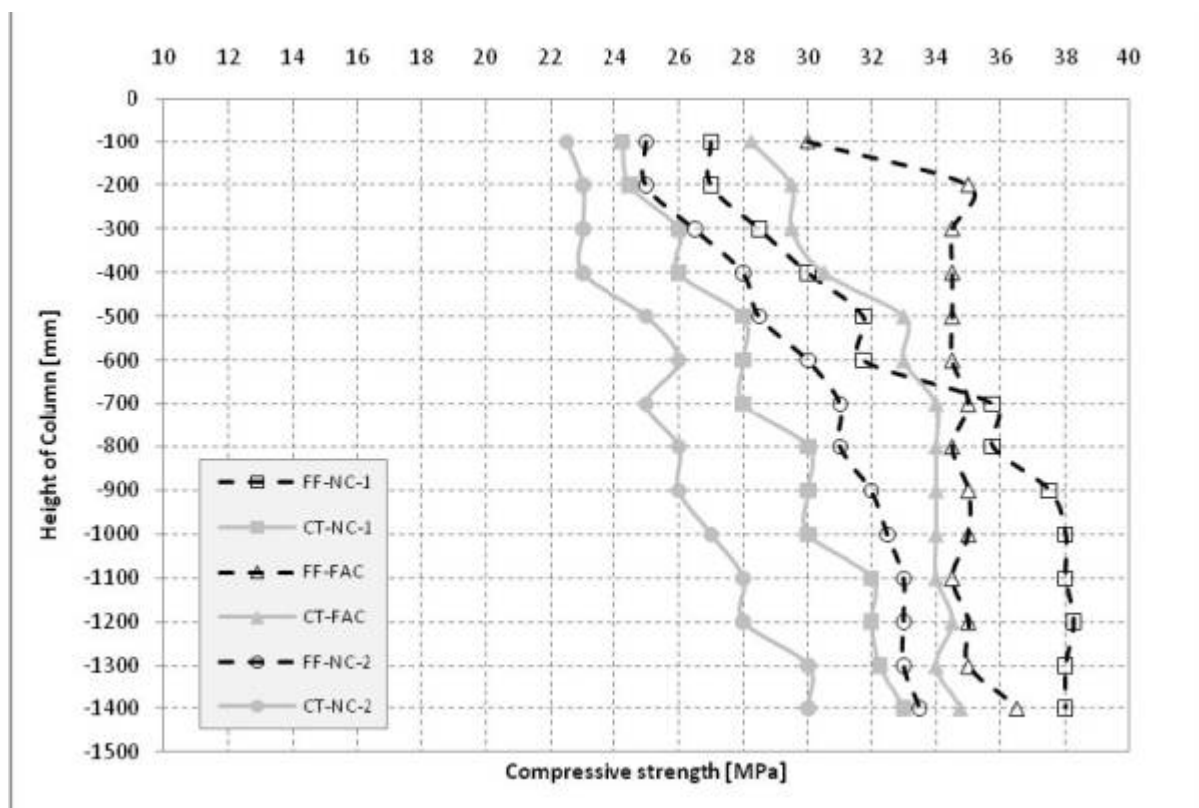
Figure 50: Results from the Rebound tests showing the variation of strength...

As seen in the chart, all columns formed with fabric showed more surface strength than those formed with cardboard. When normal concrete is used, the difference between the compressive strength of the specimens cast in cardboard versus fabric formwork at the bottom of the column is between 12 and 15%. The difference between the formworks when using flyash concrete has minimal significance (5% difference). This is an indication of flyash particles possibly clogging fabric pores and therefore, reducing the amount of water bleeding and eventually resulting in less increase in compressive strength. In

addition, regardless of the formwork type and referring to the results obtained from Schmidt hammer tests, the top end of the columns always proved to be weaker than other sections of the column. A phenomenon that appeared in both cardboard and fabric formed columns due to less compaction and less concrete density at top end of each column.

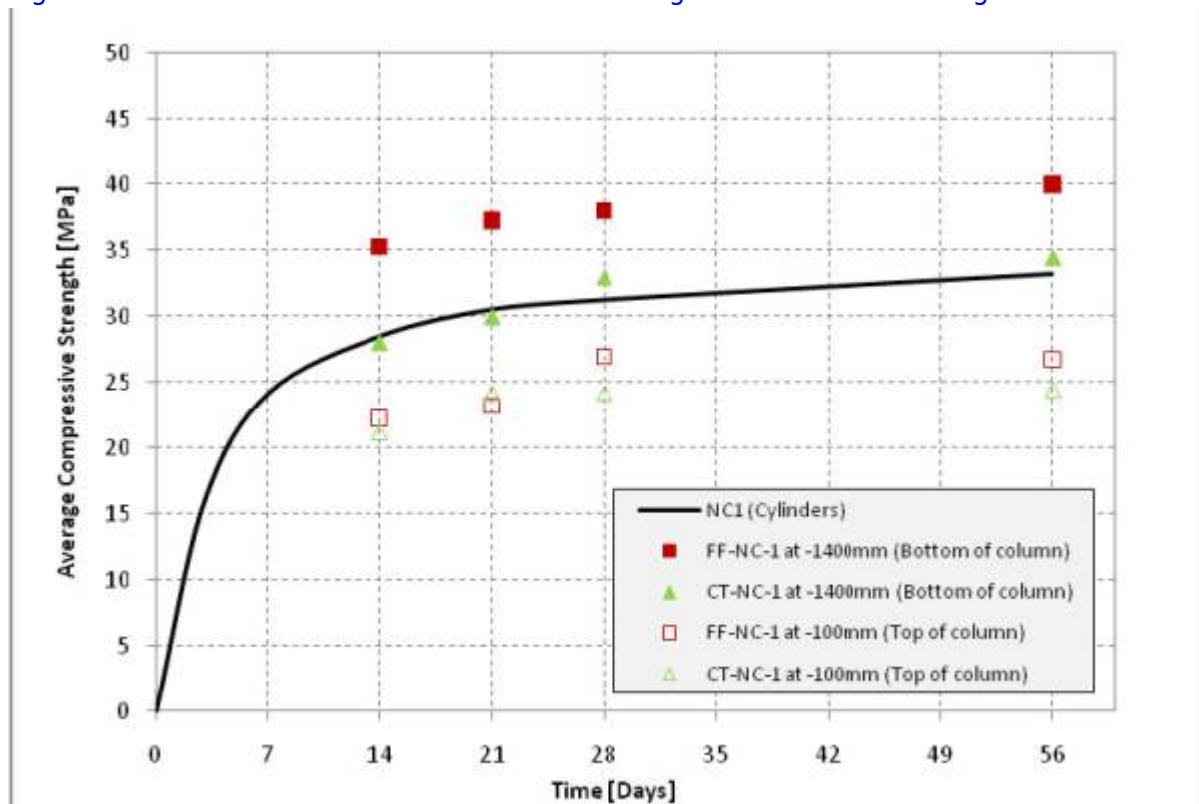
Figure 51: Normal concrete cylinders compared to Schmidt hammer results (Columns...

Compression strength test results from Schmidt hammer test have been compared to those from cylinder test for both normal and flyash concrete. As seen in Figures 51, 52 and 53, there are some fluctuations between the results obtained from Schmidt hammer and the PVC formed cylinders. The filled markers in the graph represent the bottom of the column, while the empty ones represent the top of the column.

As seen in Figure 51, compared to results from cylinder tests fabric formed column has gained an average of 21.8% extra strength at the bottom of the column while the bottom of the cardboard formed column shows almost the same results as the cylinders. At the top of the column, both cardboard and fabric formed columns showed an average of 28% less strength compared to the cylinder test results. As seen in Figure 52, cylinder test results for flyash concrete show more compressive strength than both top and bottom readings of the Schmidt hammer.

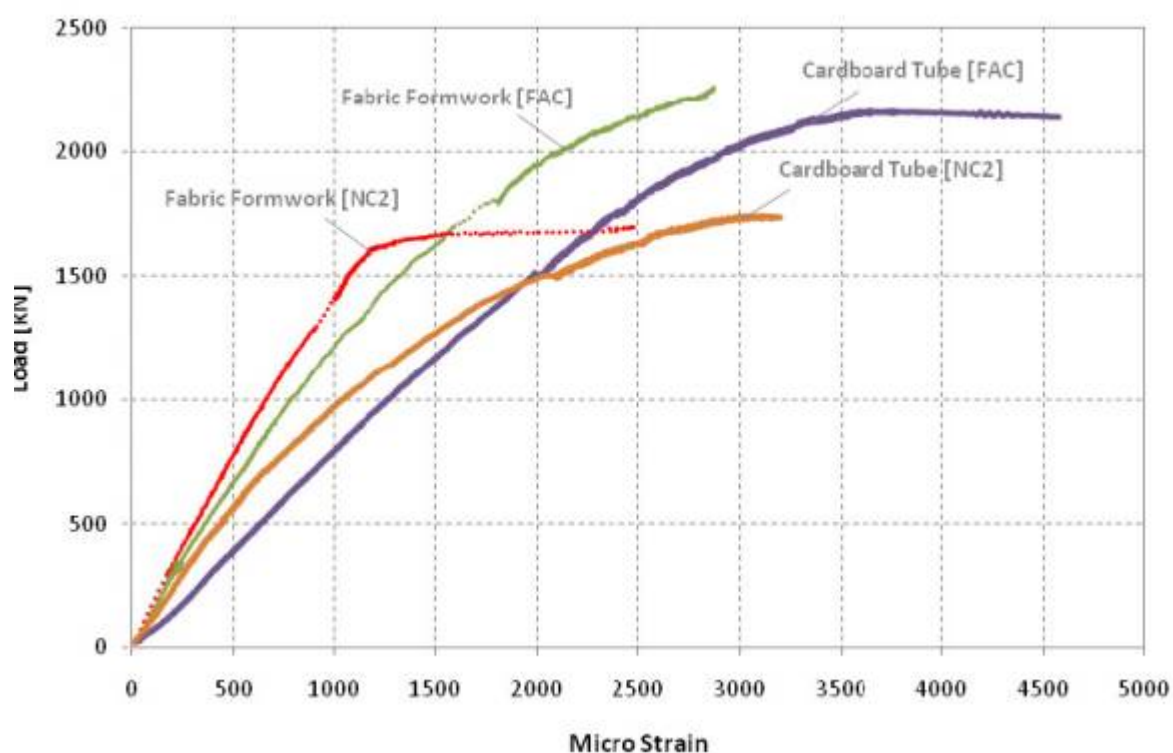
Figure 55: Maximum axial load of fabric-formed versus cardboard-formed steel...

As seen in Table 8, the first two columns (FF-NC-1 and CT-NC-1), normal concrete columns formed with fabric and cardboard, withstood 1850 kN and 2200 kN of axial load, respectively. Maximum axial load of flyash specimen (FF-FAC and CT-FAC) was 2271 kN for fabric formed column and 2165 kN for cardboard formed column. As shown in Figure 55, for the last two columns (FF-NC-2 and CT-NC-2), normal concrete columns formed with fabric and cardboard carried 1703 kN and 1744 kN of axial load, respectively.

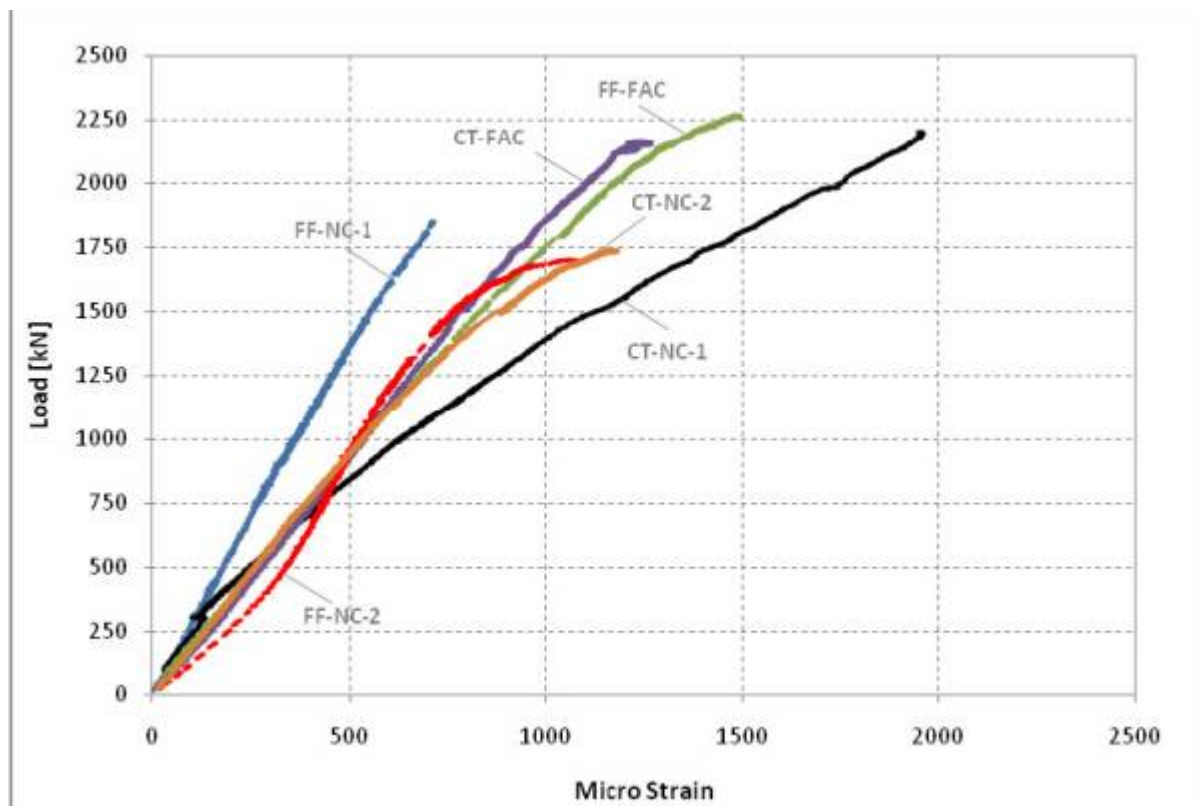
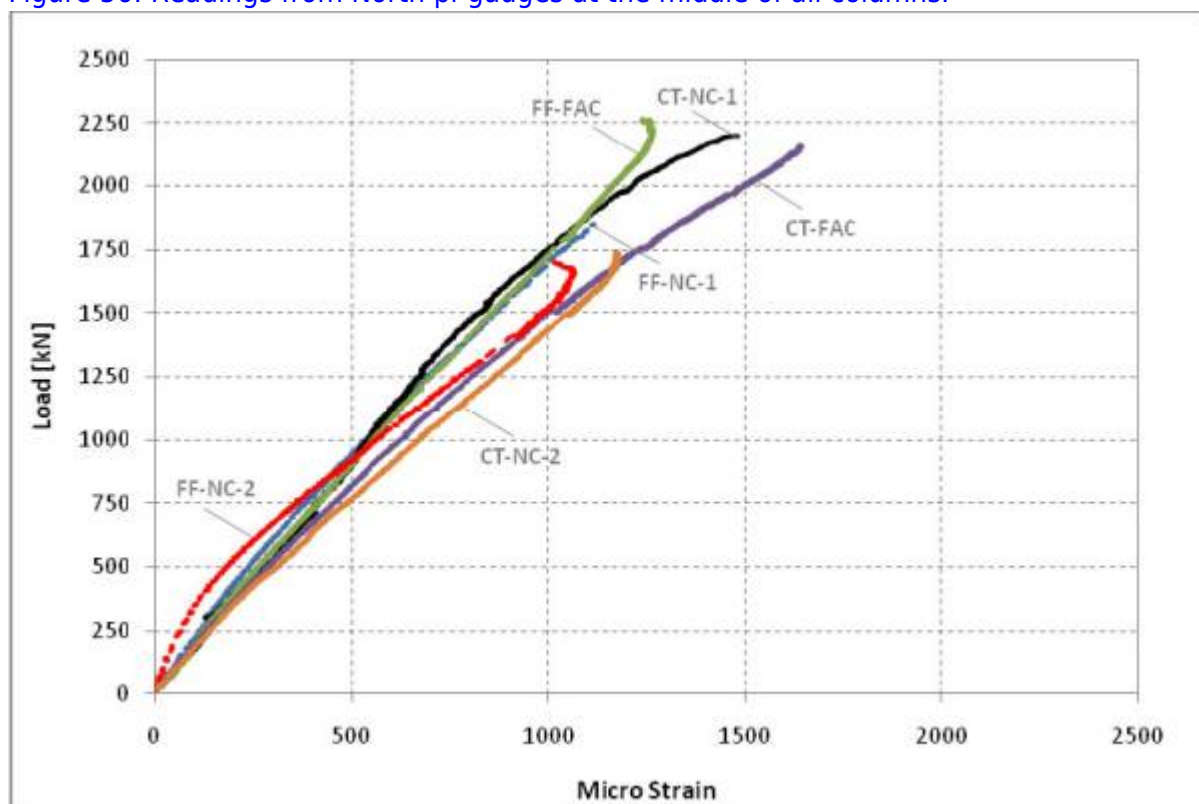
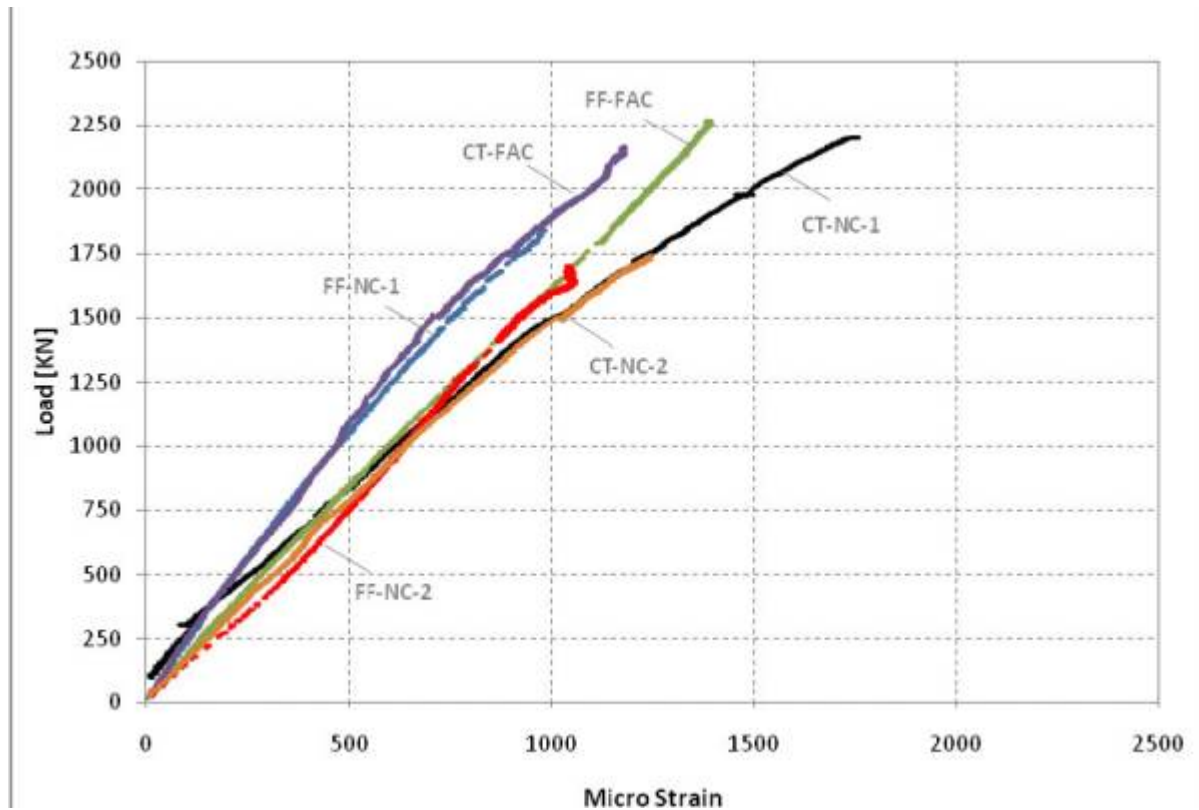
Figure 56: Readings from North pi-gauges at the middle of all columns.

Figure 57: Readings from South pi-gauges at the middle of all columns.

Figure 58: Readings from East pi-gauges at the middle of all columns.

Figure 59: Readings from West pi-gauges at the middle of all columns.

Figure 56 to 59 depict the strains in the middle, while Figures 60 to 63 depict the strains at the top of the column. Each figure represents one location either North, South, East or West and strains of that location in each column were plotted in the same graph for comparison.

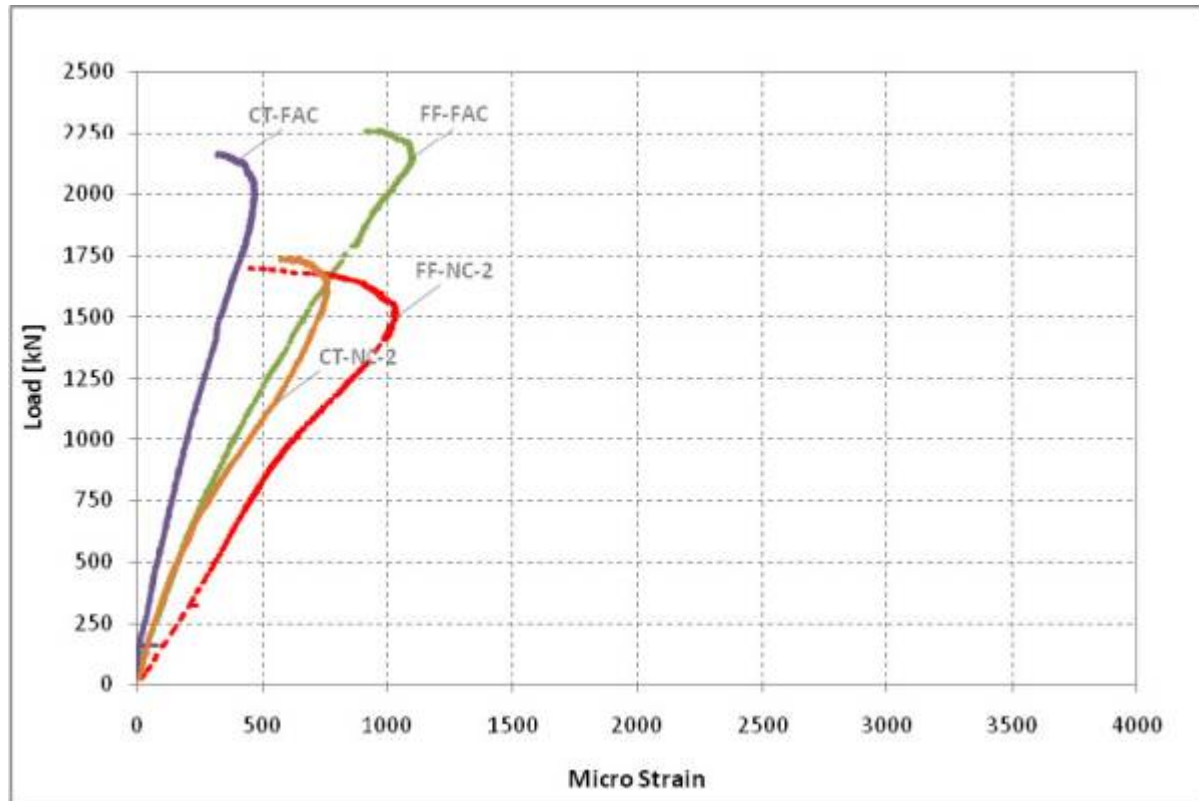
Figure 60: Readings from North pi-gauges at the top of all columns.

As seen in Figure 60 which represents the readings from North pi-gauges at the top of all columns, a trend of reverse strain close to the failure load is observed. This means that as columns were starting to crush at another location, the surrounding concrete was experiencing some tension. Figure 61 represents readings from South pi-gauges at the top of all columns. As seen in this figure, columns undergo much

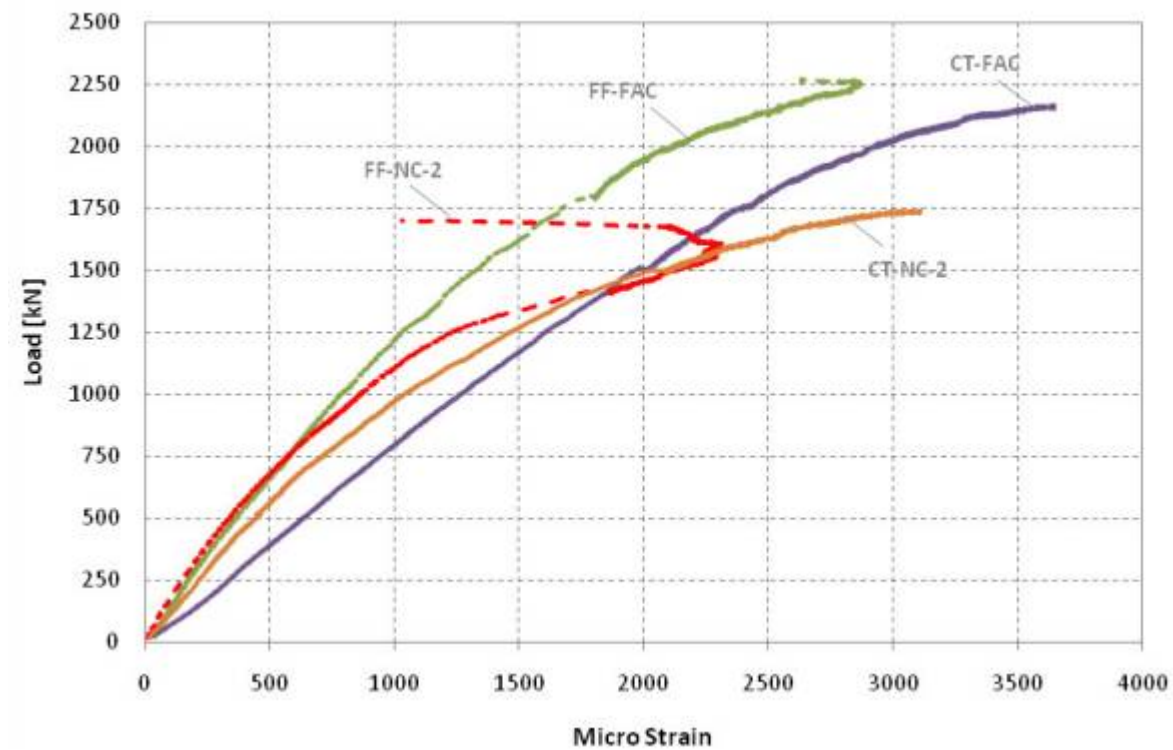
Figure 61: Readings from South pi-gauges at the top of all columns.

larger strain values as high as 3600 micro strain at the load of about 2150 kN in case of column CT-FAC. Strain values read from the south pi-gauge of column FF-NC-2 change direction from compression to tension close to the failure load. This has been caused by the uneven failure of the column at top. As seen in Figure 64, the opposite side of the column across from the south pi-gauge has failed in compression and caused some tension in south-top-zone of the column. Figure 62 which represents the readings from West pi-gauges at the top of all columns shows the highest strain in column CT-NC-2 as 3000 micro strain at the corresponding load of 1750 kN. A similar trend is observed in Figure 63 from the values taken from top-East pi-gauges. Column FF-FAC carries 2700 micro strain at the load of 2250 kN. As seen in all top pi-gauge curves, except column CT-NC-2, regardless of the form-work type, flyash concrete experienced more strain than normal concrete. As seen in Figure 65, all six columns failed at the top. This type of failure in columns has been documented before in research conducted by Bazant and Kwon [2] which found that regardless of the cross sectional size of the column, the fracture mechanism stayed the same. The reason for the top end failure is that the top end of a vertically cast member will always have less compressive strength than the lower parts of the member, due to increased pressure and compaction towards the bottom of the mold [3]. This holds true regardless of the formwork used.

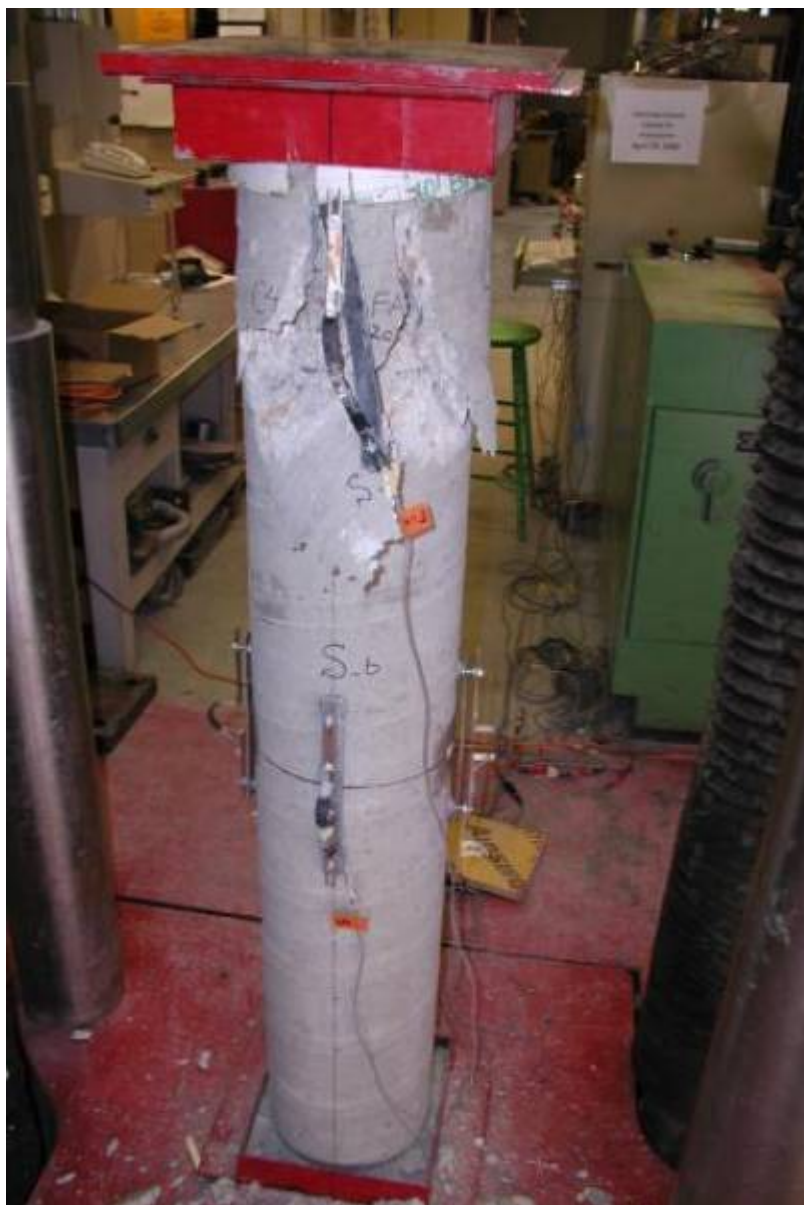
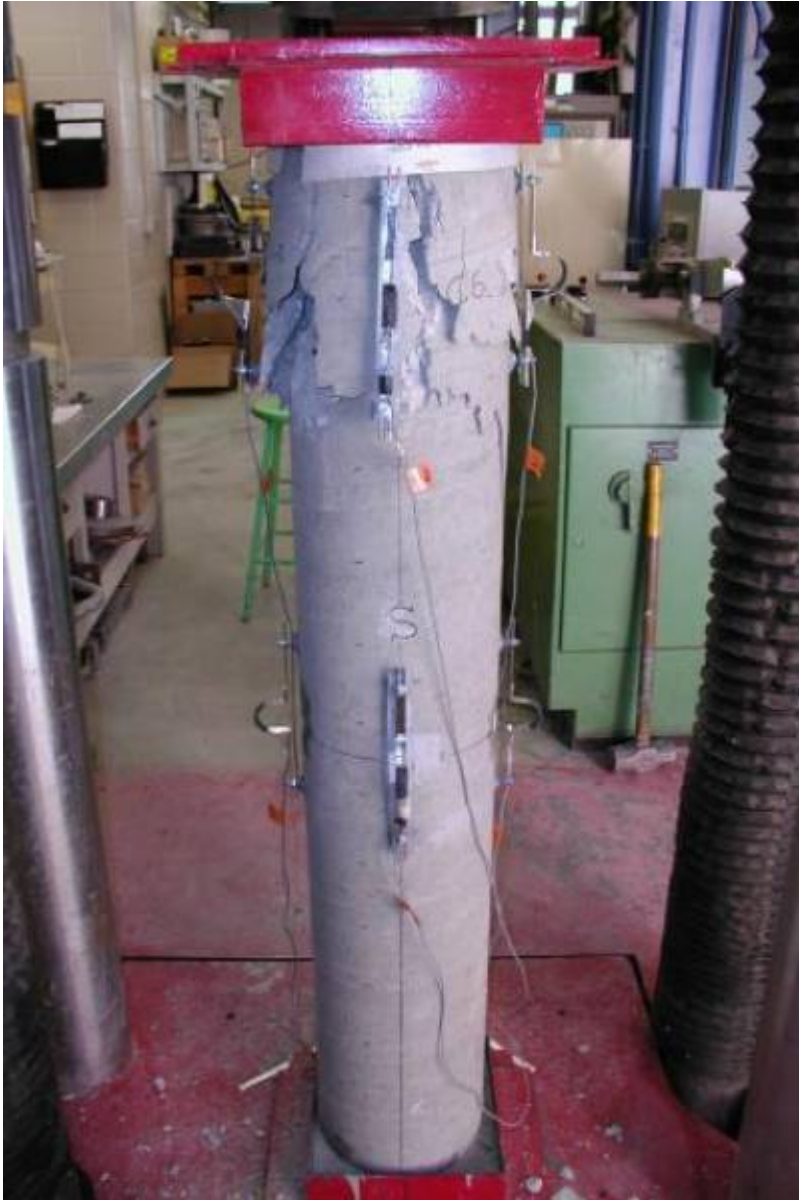
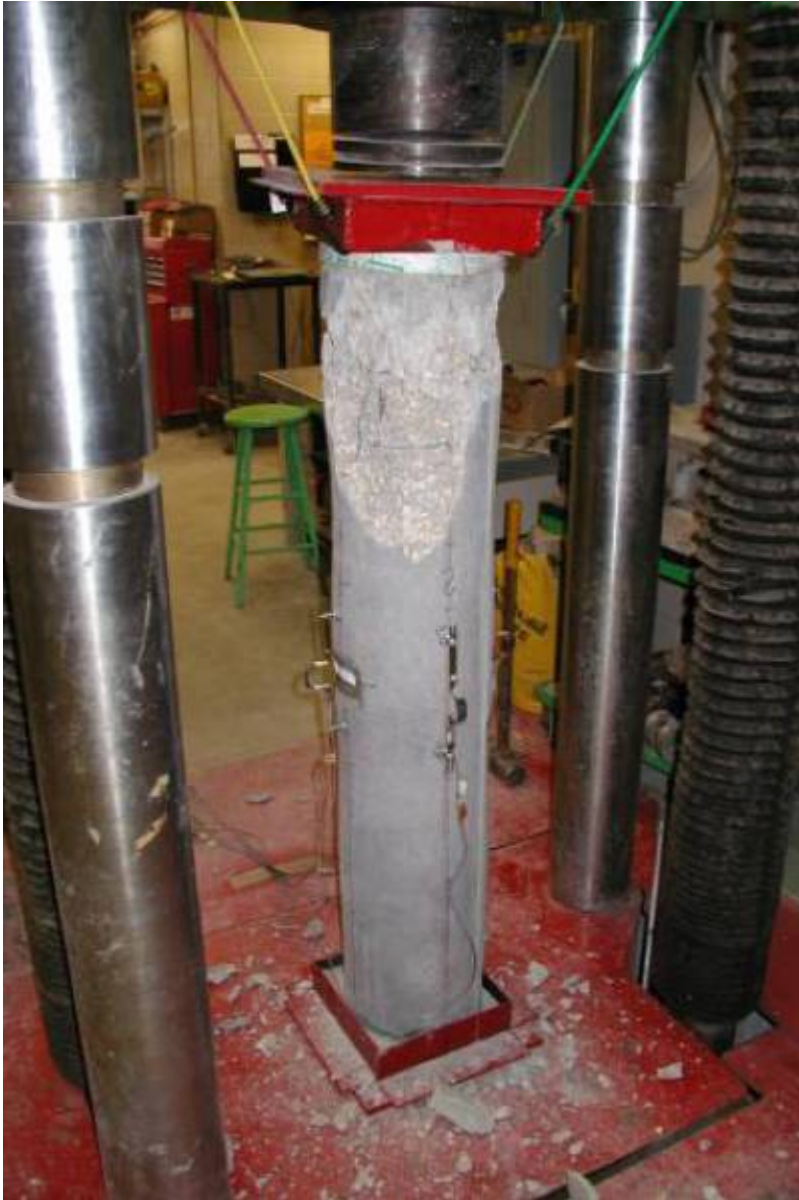
Figure 64: Column FF-NC-2 after failure.

Figure 65: Column CT-FAC after failure.

Figure 65: Column CT-NC-1 after failure.

Figure 65: Column CT-NC-2 after failure.

Figure 65: Column FF-FAC after failure.

Figure 65: Column FF-NC-1 after failure.

In order to be able to better observe behaviour and the failure pattern of the columns, all tests were videotaped. The failure pattern of the columns was a factor to be investigated in this phase of the study. Based on observations of the two cardboard and two fabric-formed column tested, the failure of the cardboard formed column started with crushing on top and then spalling till failure. Cardboard-formed columns presented a typical gradual failure with no sign of brittleness, no longitudinal cracks and no flaking. On the other hand, fabric-formed columns started with crushing on top and development of longitudinal cracks at the same time along with spalling. Also, some flaking and relative sudden failure of

outside surface was observed. Photographs of these column failures are shown in Figure 65 (page 82).

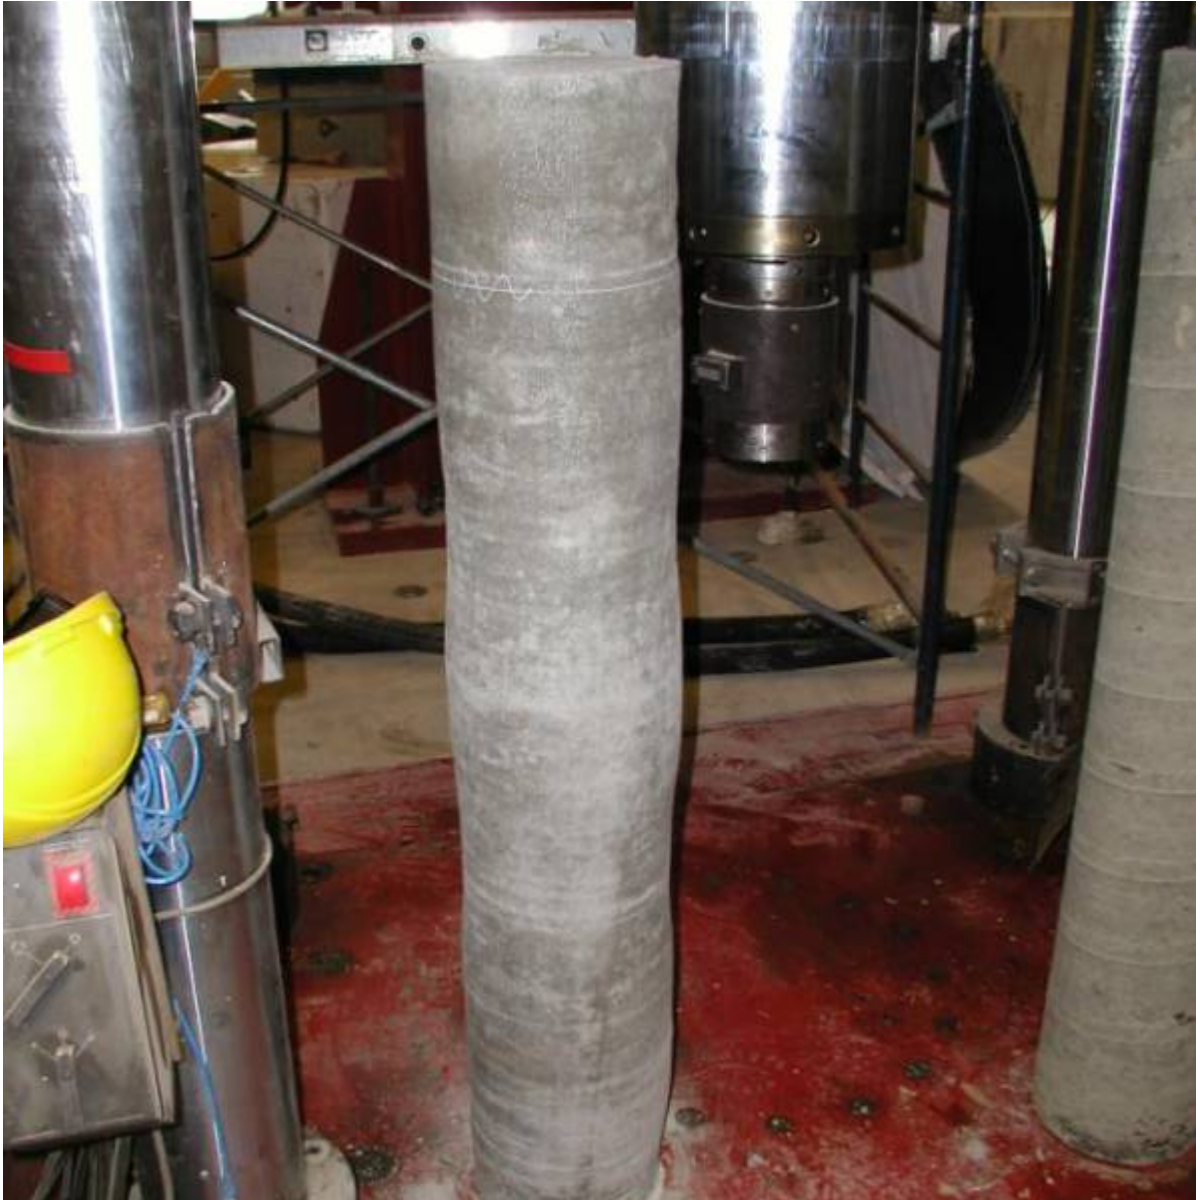
Figure 67: Bulged concrete column.

Our first attempt of casting a concrete column using fabric formwork was not quite successful. The column was bulgy at some points and it did not have constant diameter along its length while cardboard molds that are industrially manufactured are perfectly symmetrical tubes and form perfectly symmetrical columns. The reason for this problem was that the fabric was sandwiched between the boards using bolts and when the concrete was poured inside the mold, the hoop tension created by the liquid concrete pulled the fabric out between the bolts (Figure 66). Areas supported by bolts resisted the pressure while parts away from bolts deformed creating bulges along the length of the hardened concrete column, as shown in Figure 67.
