# Column Tests

In order to evaluate the effect of fabric formwork on structural behaviour of a column, full size fabric-formed and conventionally formed reinforced concrete columns were de-signed and tested to failure under concentric axial load. The variables in these tests were two types of formwork; permeable fabric versus cardboard and two types of concrete; Flyash concrete and normal concrete. The fabric of choice was Geotex 315ST due to its better surface finish.

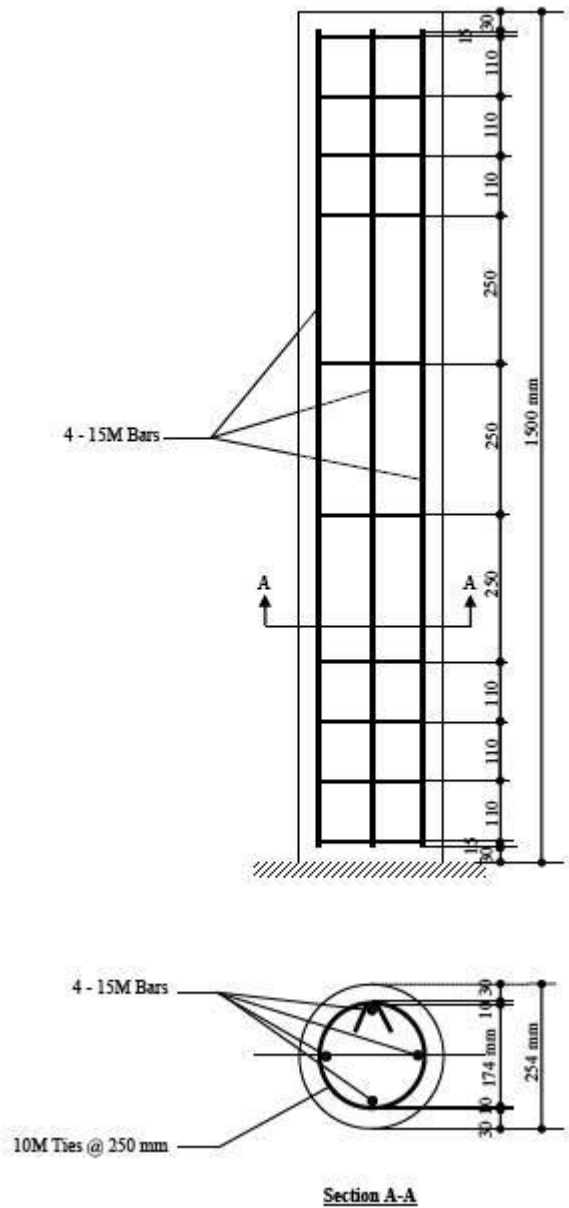
All columns had 254 mm radius and the column height was limited to 1500 mm. Based on calculations, four 15M bars were considered as the longitudinal bars, tie size was se-lected as 10M and tie spacing(s) was calculated as 250 mm (center to centre) and tie hooks, were set as 135 degrees. Arrangement and configuration of the reinforcement in the column has been shown in Figure 42.

Figure 42: Column reinforcement details.

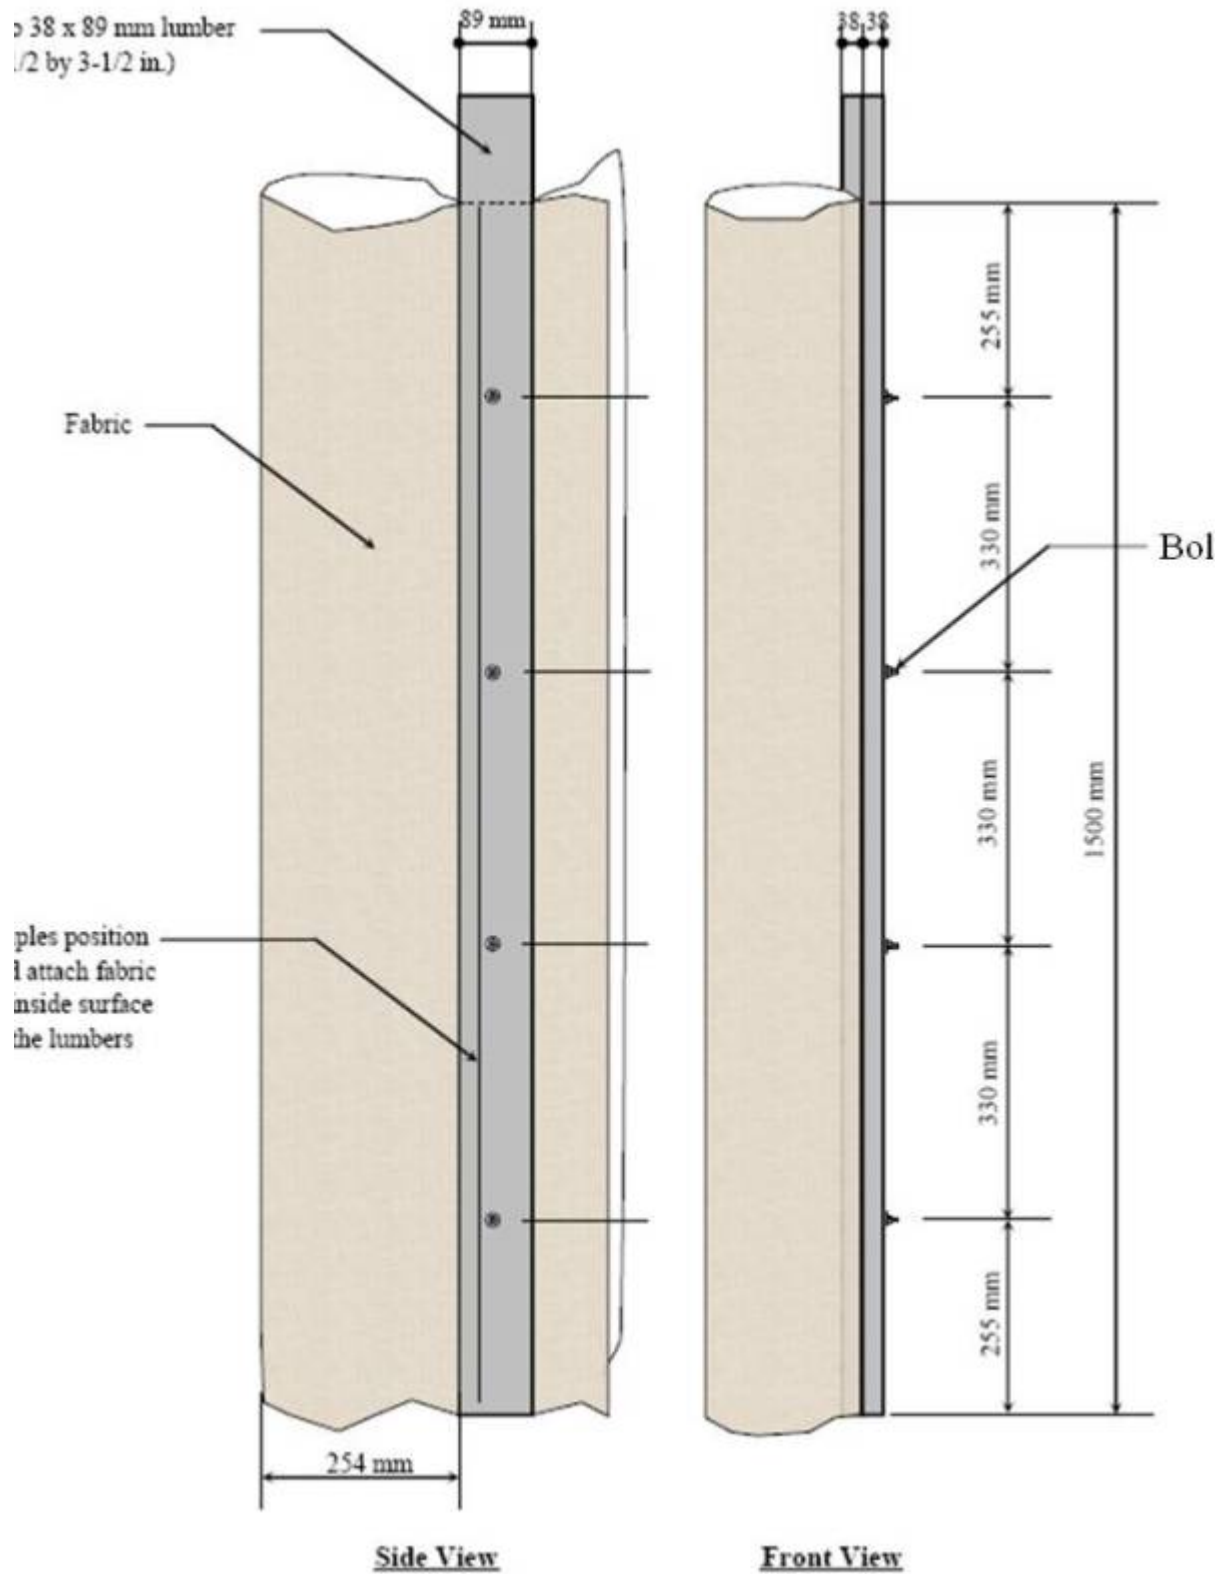
batch. The columns were cast using normal concrete and flyash concrete. Total of 6 columns were cast. As shown in Figure 43, the formwork was essentially the same as that used to cast the earlier cylinder specimens. The formwork was made of a single, rectangular, piece of fabric sandwiched between two vertical pieces of 38 x 89 mm lumber (2" by 4"). The fabric was first fitted to create the proper diameter and stapled to the lumber pieces.

Figure 43: Configuration of the fabric formwork for reinforced concrete column.

from each other (though less staples would be probably also sufficient), providing a stitch line from top to bottom of the formwork. Orientation of the stitch line can be seen in Figure 43. Stapling provided an even distribution of the hoop forces along the height of the formwork and resulted in a uniform cylindrical geometry. The variation in diameter of the column along its length was dramatically reduced as demonstrated in Figure 68.

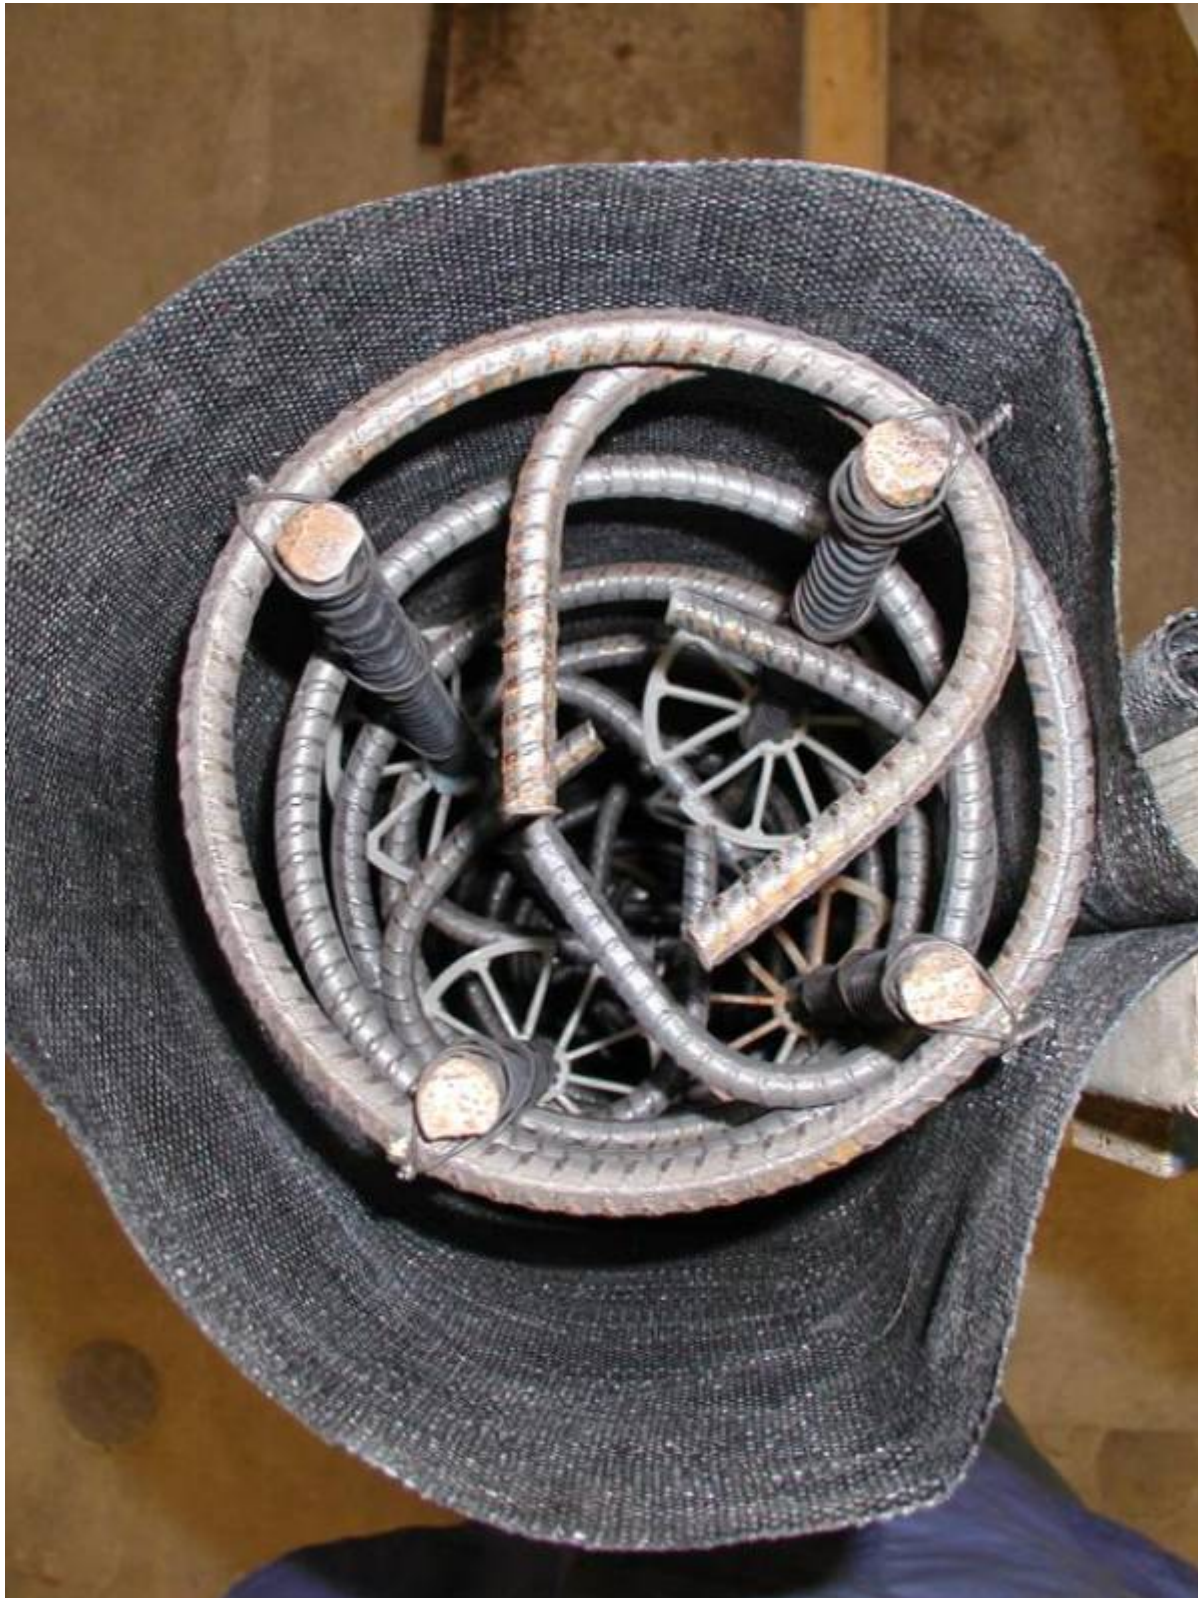
«fs medium>The cover distance between both fabric and cardboard formworks was maintained by using plastic wheel spacers on the longitudinal bars. These spacers were also used to keep the reinforcement cage in the centre of the formwork during casting as shown in Figure 46.</fs>

Figure 46: Reinforcement cage.

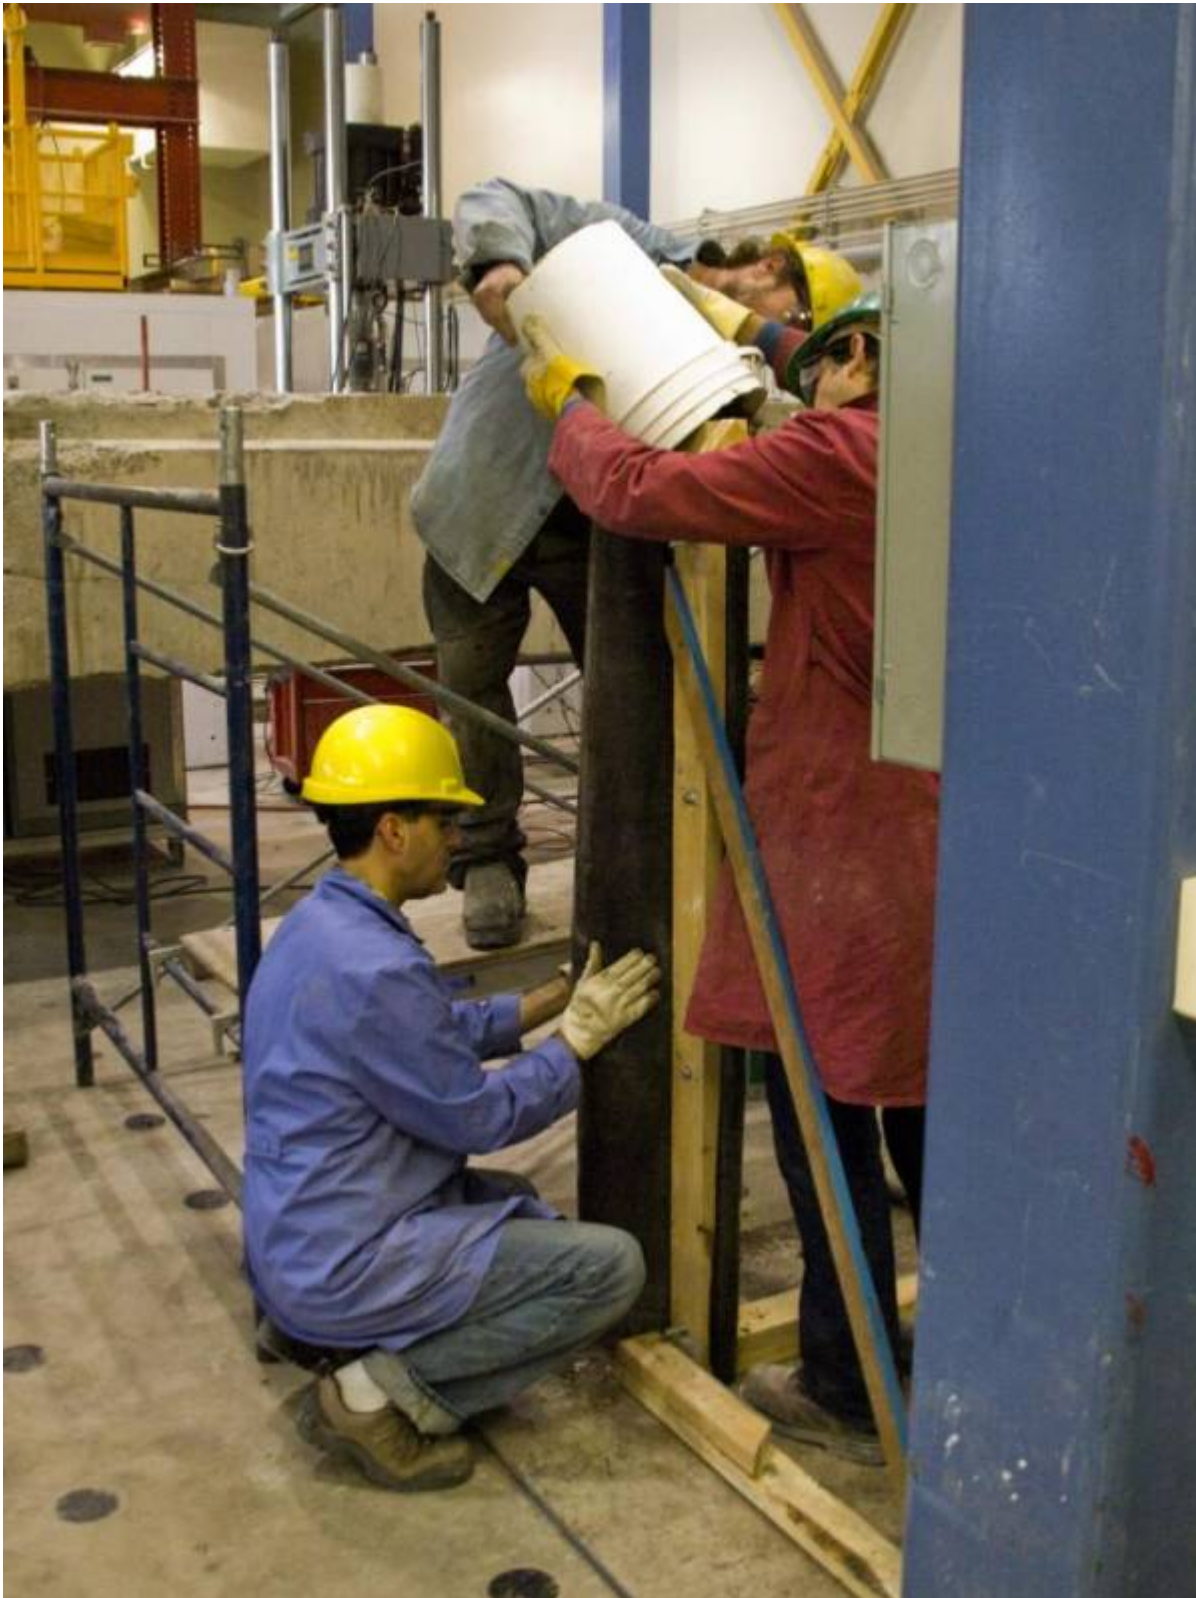
When the concrete was delivered, the slump value was measured and fifteen 101 by 203 mm (4 by 8 in.) PVC control compressive strength test specimens were cast. Fresh concrete was transferred by hand directly from the truck mixer's discharge chute to buckets and then into the forms as demonstrated in Figure 47. Each specimen was vibrated both inside and outside, using a portable electric internal vibrator at 5 to 15 second intervals. In case of fabric formwork, hand tapping the mold wall was also used to vibrate the concrete and help the bleeding of the air bubbles and extra water from the concrete. All columns and companion cylinders were cured in the same manner. Forms were stripped after one day, after which the columns, as well as the control samples were cured for another 3 days using wet burlap and plastic sheets as vapour barrier cover. Unlike in the cardboard formed columns, no sign of color variation was observed in fabric formed columns. No imperfections such as bug holes or the appearance of large aggregates were seen on the fabric-formed concrete surface. Such column could be easily used as exposed concrete structural members with no necessity for expensive patch ups, epoxy coatings or paintings or architectural veneers.

Figure 47: casting of column in fabric formwork.

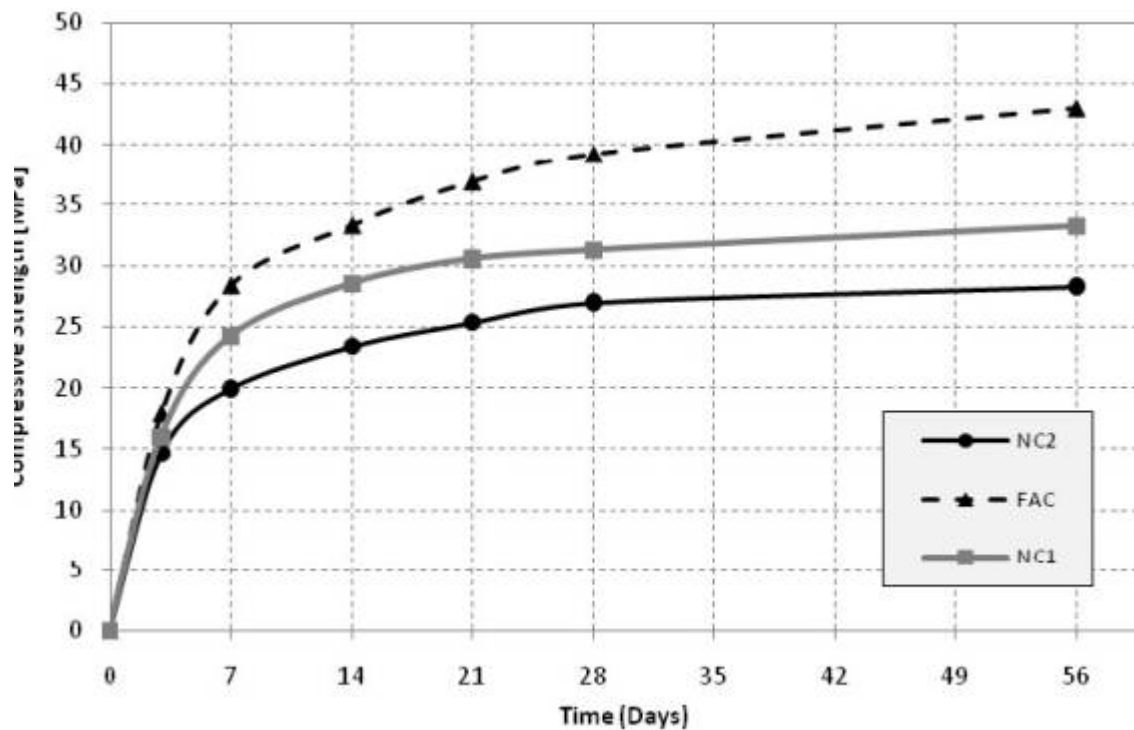
A compression testing machine was used to test the companion 101 by 203 mm (4 by 8 in.) concrete cylinders at the ages of 3, 7, 14, 28 and 56 days. All cured columns and the concrete cylinders were taken out of their molds simultaneously and were kept in the laboratory till testing. Figure 49 provides the data concluded from the cylinder compression tests. Both batches were specified to reach compressive strength of 25 MPa at 28 days but as the results show, the flyash concrete gained more compressive strength compared to the normal concrete. As seen in Figure 49, average compressive strength of the flyash sample at 28 days was measured as 39.2 MPa while the normal concrete specimens had average compression strength of 27 and 28.30 MPa. The actual compressive strength in both concretes was used to estimate the actual maximum axial load capacity of the columns.

Figure 49: Concrete strength gain with time.

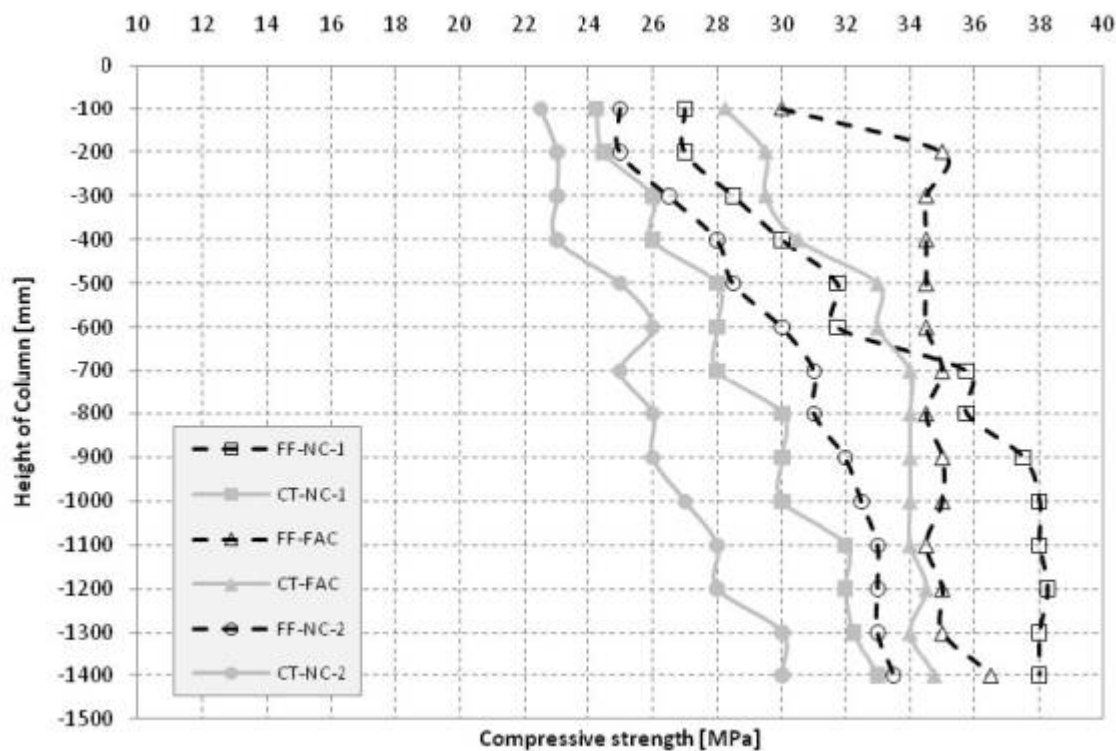
As seen in the chart, all columns formed with fabric showed more surface strength than those formed with cardboard. When normal concrete is used, the difference between the compressive strength of the specimens cast in cardboard versus fabric formwork at the bottom of the column is between 12 and 15%. The difference between the formworks when using flyash concrete has minimal significance (5% difference). This is an indication of flyash particles possibly clogging fabric pores and therefore, reducing the amount of water bleeding and eventually resulting in less increase in compressive strength. In

addition, regardless of the formwork type and referring to the results obtained from Schmidt hammer tests, the top end of the columns always proved to be weaker than other sections of the column. A phenomenon that appeared in both cardboard and fabric formed columns due to less compaction and less concrete density at top end of each column.

Figure 50: Results from the Rebound tests showing the variation of strength...

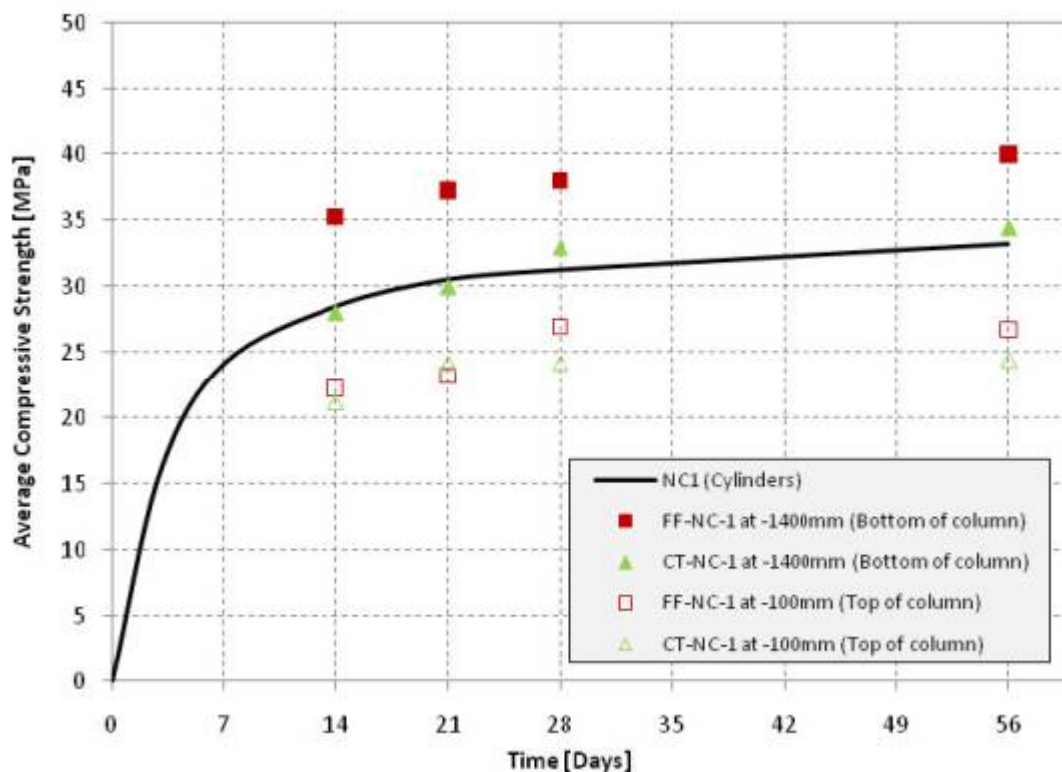
As seen in Figure 51, compared to results from cylinder tests fabric formed column has gained an average of 21.8% extra strength at the bottom of the column while the bottom of the cardboard formed column shows almost the same results as the cylinders. At the top of the column, both cardboard and fabric formed columns showed an average of 28% less strength compared to the cylinder test results. As seen in Figure 52, cylinder test results for flyash concrete show more compressive strength than both top and bottom readings of the Schmidt hammer.

Figure 51: Normal concrete cylinders compared to Schmidt hammer results (Columns...

Compression strength test results from Schmidt hammer test have been compared to those from cylinder test for both normal and flyash concrete. As seen in Figures 51, 52 and 53, there are some fluctuations between the results obtained from Schmidt hammer and the PVC formed cylinders. The filled markers in the graph represent the bottom of the column, while the empty ones represent the top of the column.

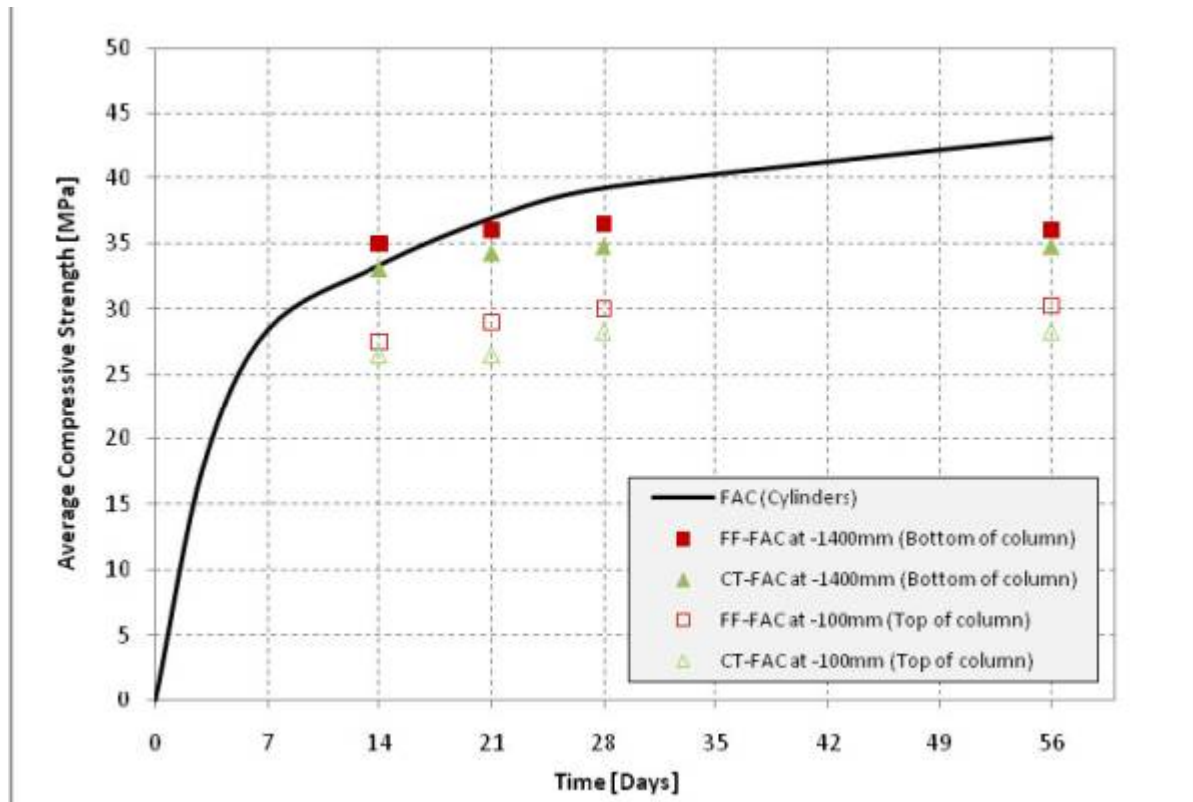
Figure 52: Flyash concrete cylinders compared to Schmidt hammer results (Columns...

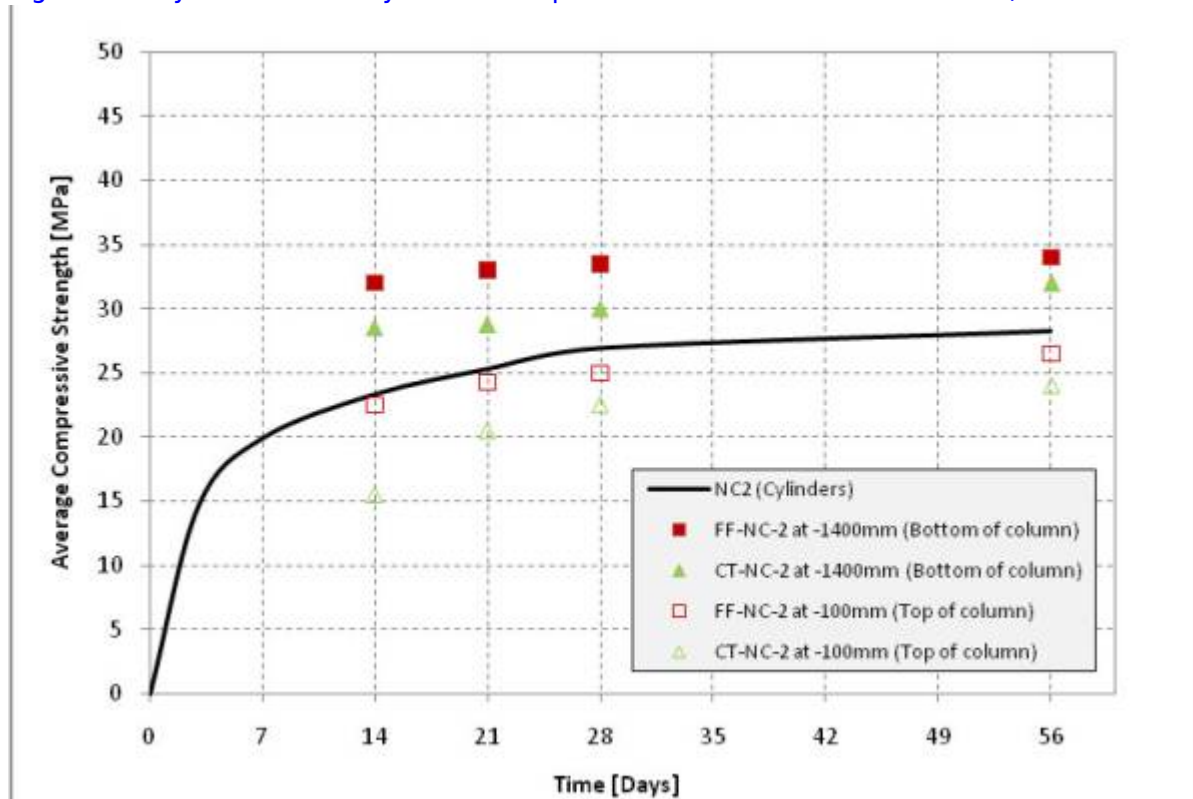
The difference between the readings of the Schmidt hammer at different ages stays constant but for some reason does not follow the strength indicated from cylinder tests. For the second set of normal concrete columns and cylinders, it can be seen in Figure 53 that compared to results from cylinder tests, fabric formed column has gained an average of 28% extra strength at the bottom of the column while cardboard formed column shows 14% difference. Schmidt hammer reading from the top of the columns shows 15% less compressive strength for cardboard formed columns and 6% less for fabric formed columns.

Figure 53: Normal concrete cylinders compared to Schmidt hammer results (Columns...

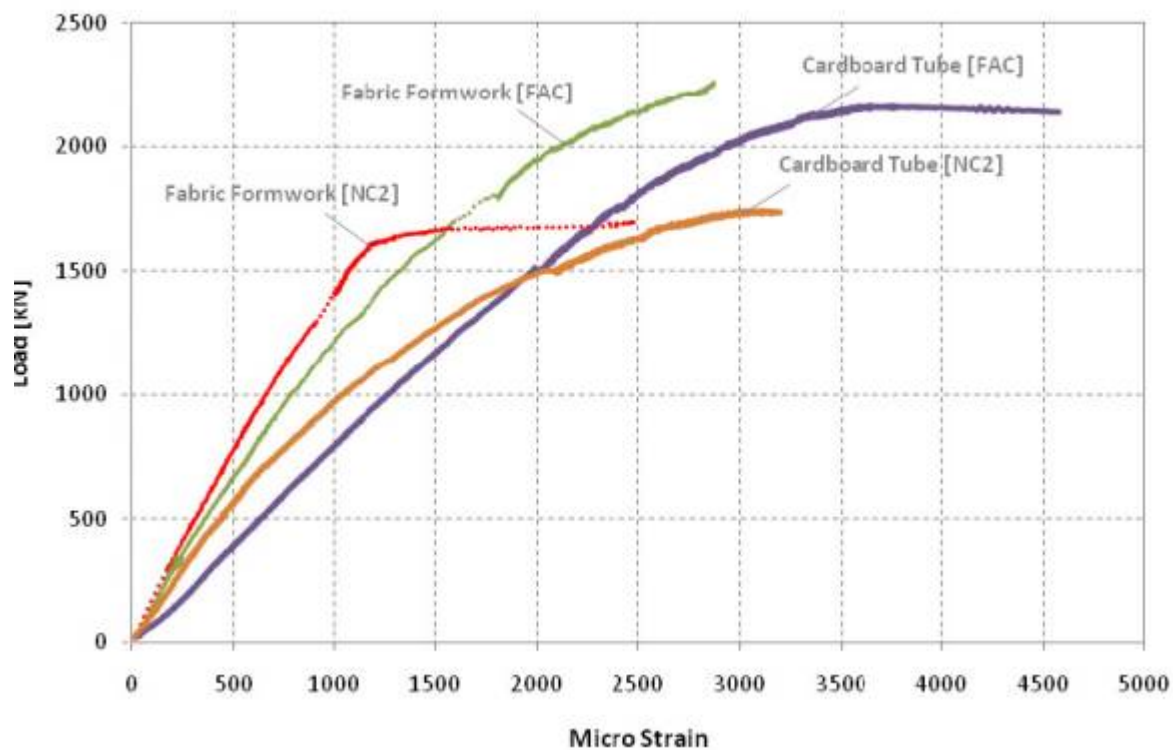
As seen in Table 8, the first two columns (FF-NC-1 and CT-NC-1), normal concrete columns formed with fabric and cardboard, withstood 1850 kN and 2200 kN of axial load, respectively. Maximum axial load of flyash specimen (FF-FAC and CT-FAC) was 2271 kN for fabric formed column and 2165 kN for cardboard formed column. As shown in Figure 55, for the last two columns (FF-NC-2 and CT-NC-2), normal concrete columns formed with fabric and cardboard carried 1703 kN and 1744 kN of axial load, respectively.

Figure 55: Maximum axial load of fabric-formed versus cardboard-formed steel...

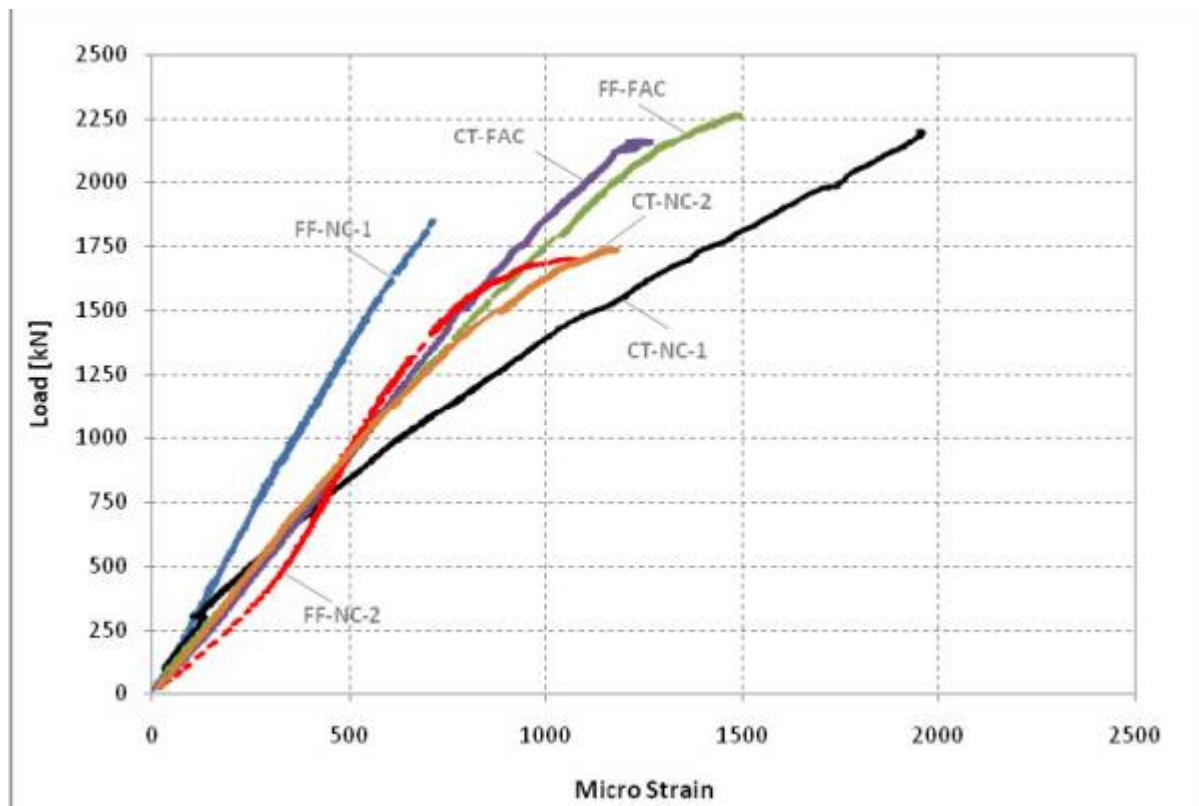
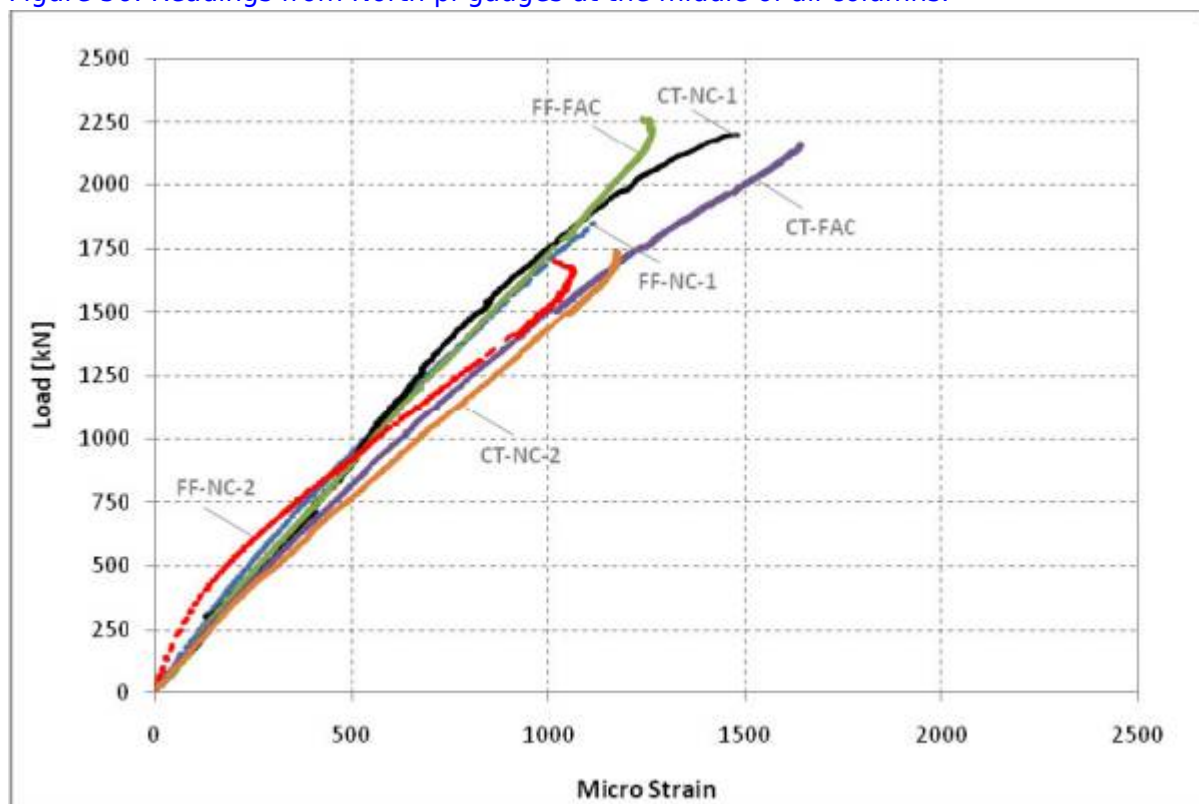
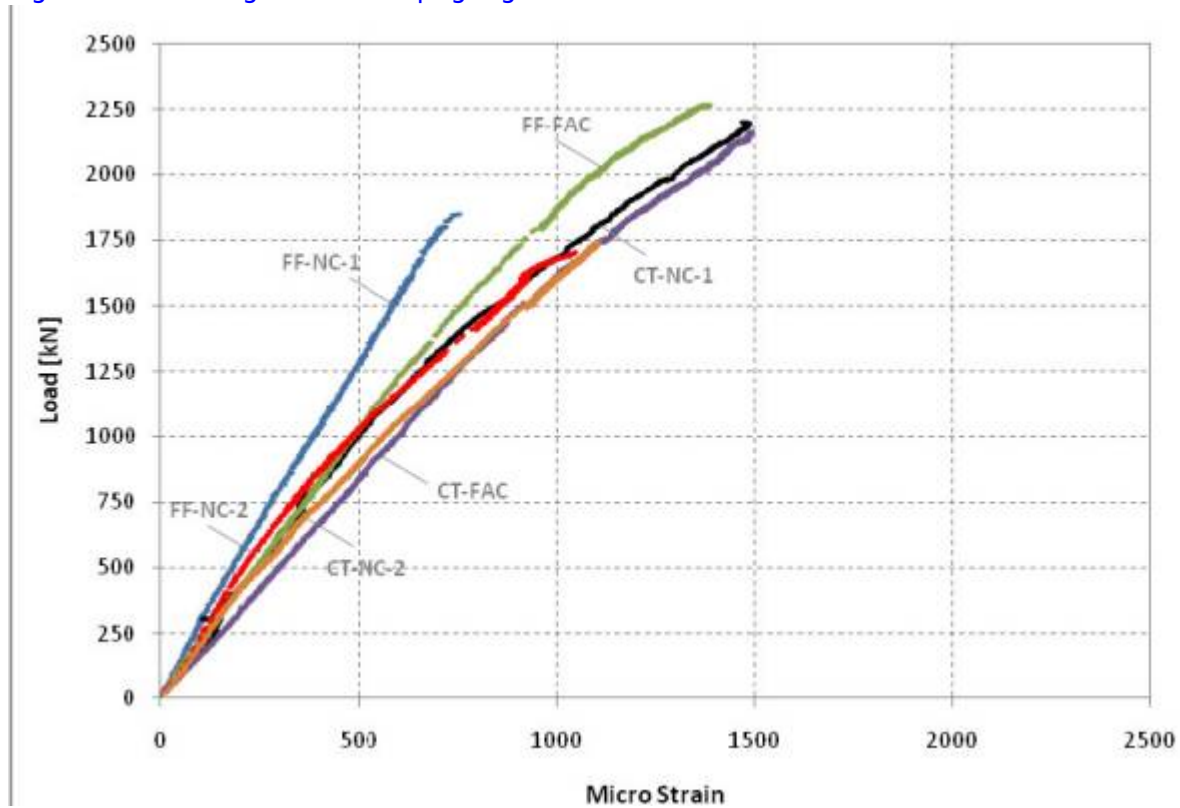
Figure 56 to 59 depict the strains in the middle, while Figures 60 to 63 depict the strains at the top of the column. Each figure represents one location either North, South, East or West and strains of that location in each column were plotted in the same graph for comparison.

Figure 56: Readings from North pi-gauges at the middle of all columns.

Figure 57: Readings from South pi-gauges at the middle of all columns.

Figure 58: Readings from East pi-gauges at the middle of all columns.

Figure 59: Readings from West pi-gauges at the middle of all columns.

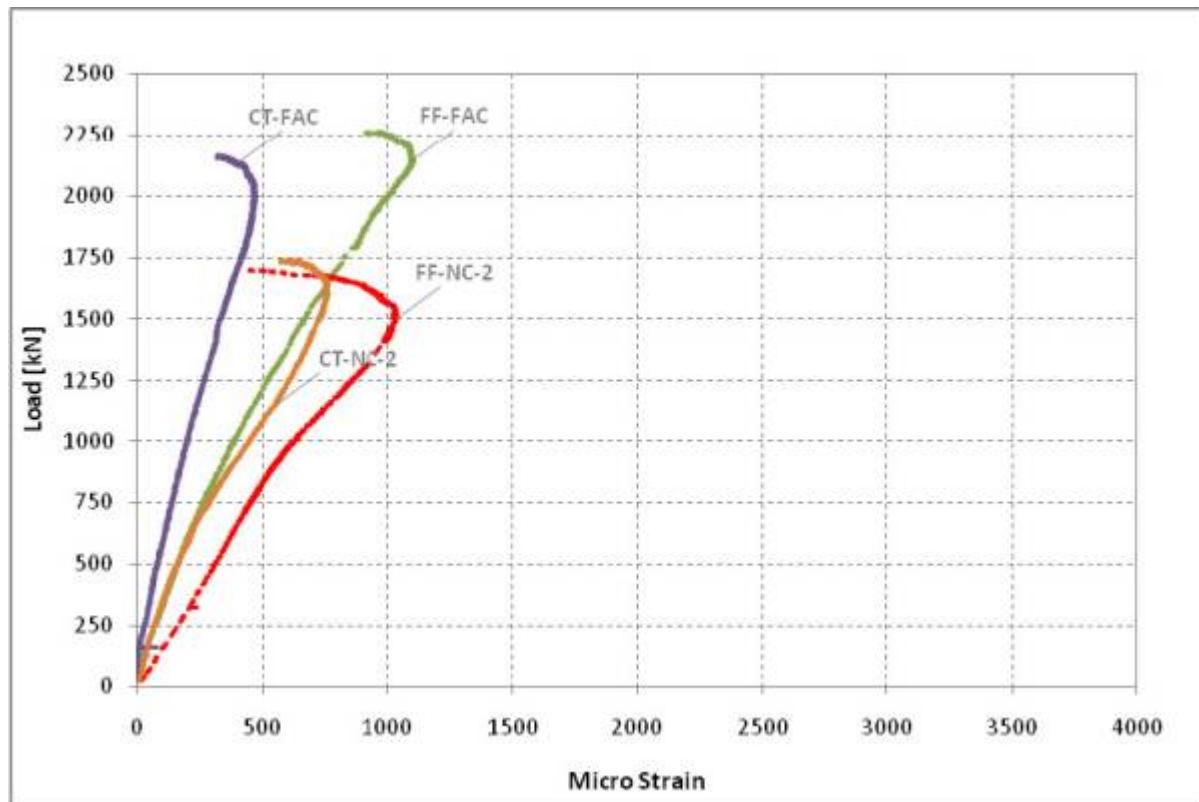
Figure 60: Readings from North pi-gauges at the top of all columns.

As seen in Figure 60 which represents the readings from North pi-gauges at the top of all columns, a trend of reverse strain close to the failure load is observed. This means that as columns were starting to crush at another location, the surrounding concrete was experiencing some tension. Figure 61 represents readings from South pi-gauges at the top of all columns. As seen in this figure, columns undergo much

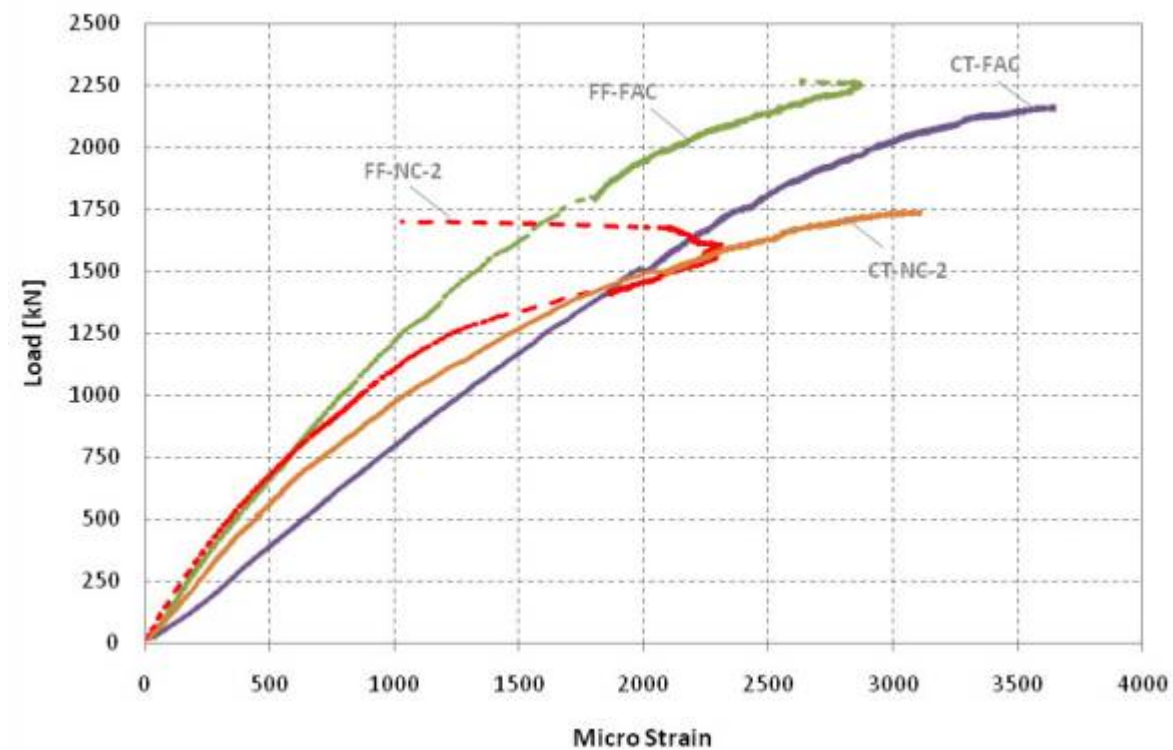
Figure 61: Readings from South pi-gauges at the top of all columns.

larger strain values as high as 3600 micro strain at the load of about 2150 kN in case of column CT-FAC. Strain values read from the south pi-gauge of column FF-NC-2 change direction from compression to tension close to the failure load. This has been caused by the uneven failure of the column at top. As seen in Figure 64, the opposite side of the column across from the south pi-gauge has failed in compression and caused some tension in south-top-zone of the column. Figure 62 which represents the readings from West pi-gauges at the top of all columns shows the highest strain in column CT-NC-2 as 3000 micro strain at the corresponding load of 1750 kN. A similar trend is observed in Figure 63 from the values taken from top-East pi-gauges. Column FF-FAC carries 2700 micro strain at the load of 2250 kN. As seen in all top pi-gauge curves, except column CT-NC-2, regardless of the form-work type, flyash concrete experienced more strain than normal concrete. As seen in Figure 65, all six columns failed at the top. This type of failure in columns has been documented before in research conducted by Bazant and Kwon [2] which found that regardless of the cross sectional size of the column, the fracture mechanism stayed the same. The reason for the top end failure is that the top end of a vertically cast member will always have less compressive strength than the lower parts of the member, due to increased pressure and compaction towards the bottom of the mold [3]. This holds true regardless of the formwork used.

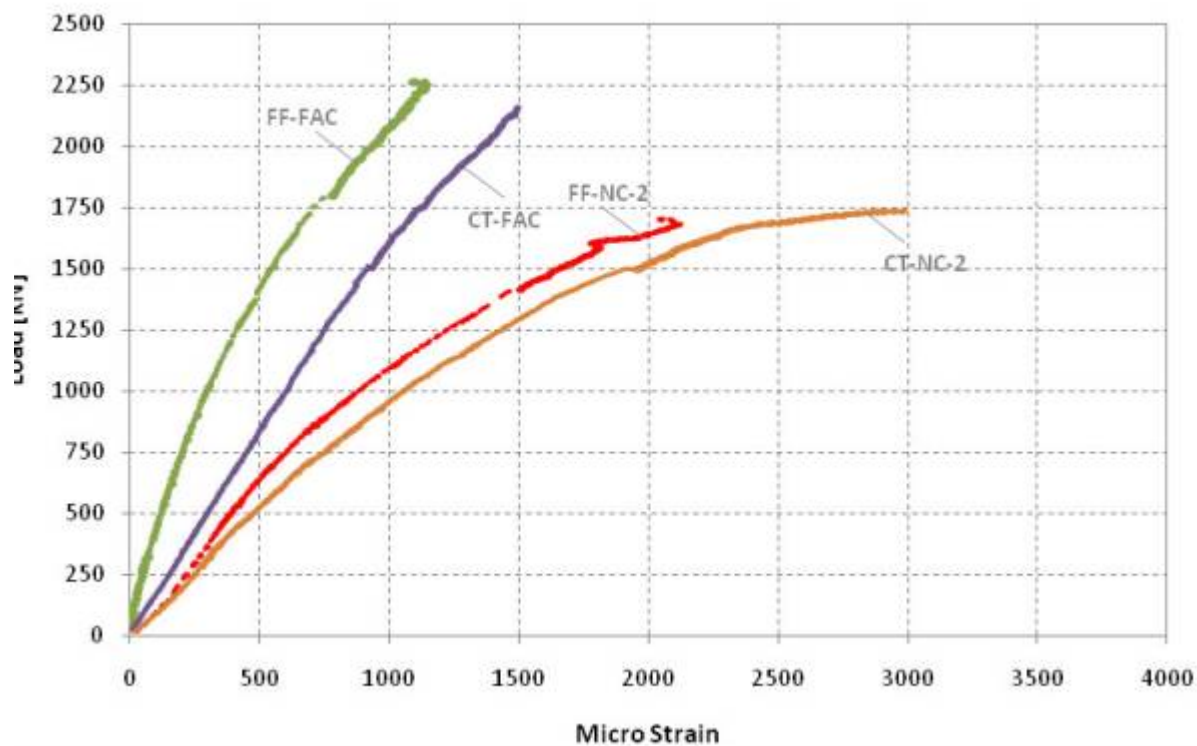
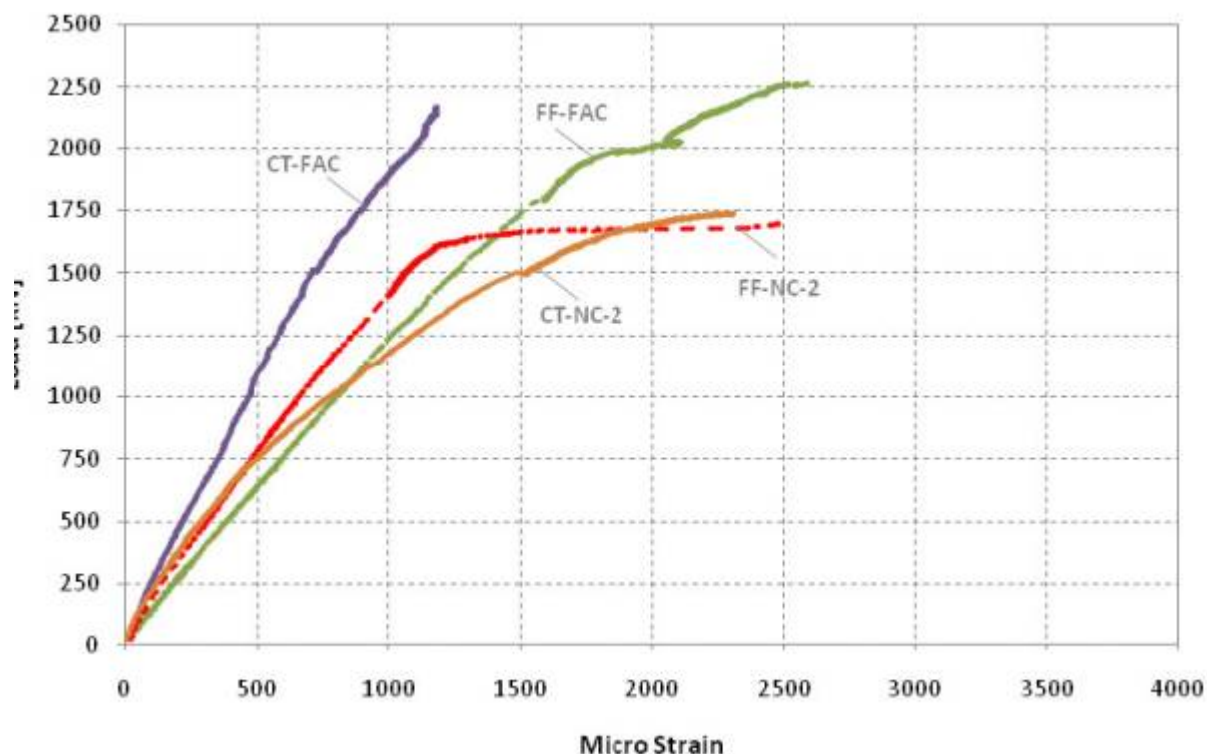
Figure 62: Readings from West pi-gauges at the top of all columns.

Figure 63: Readings from East pi-gauges at the top of all columns.
