# Column Tests

In order to evaluate the effect of fabric formwork on structural behaviour of a column, full size fabric-formed and conventionally formed reinforced concrete columns were de-signed and tested to failure under concentric axial load. The variables in these tests were two types of formwork; permeable fabric versus cardboard and two types of concrete; Flyash concrete and normal concrete. The fabric of choice was Geotex 315ST due to its better surface finish.

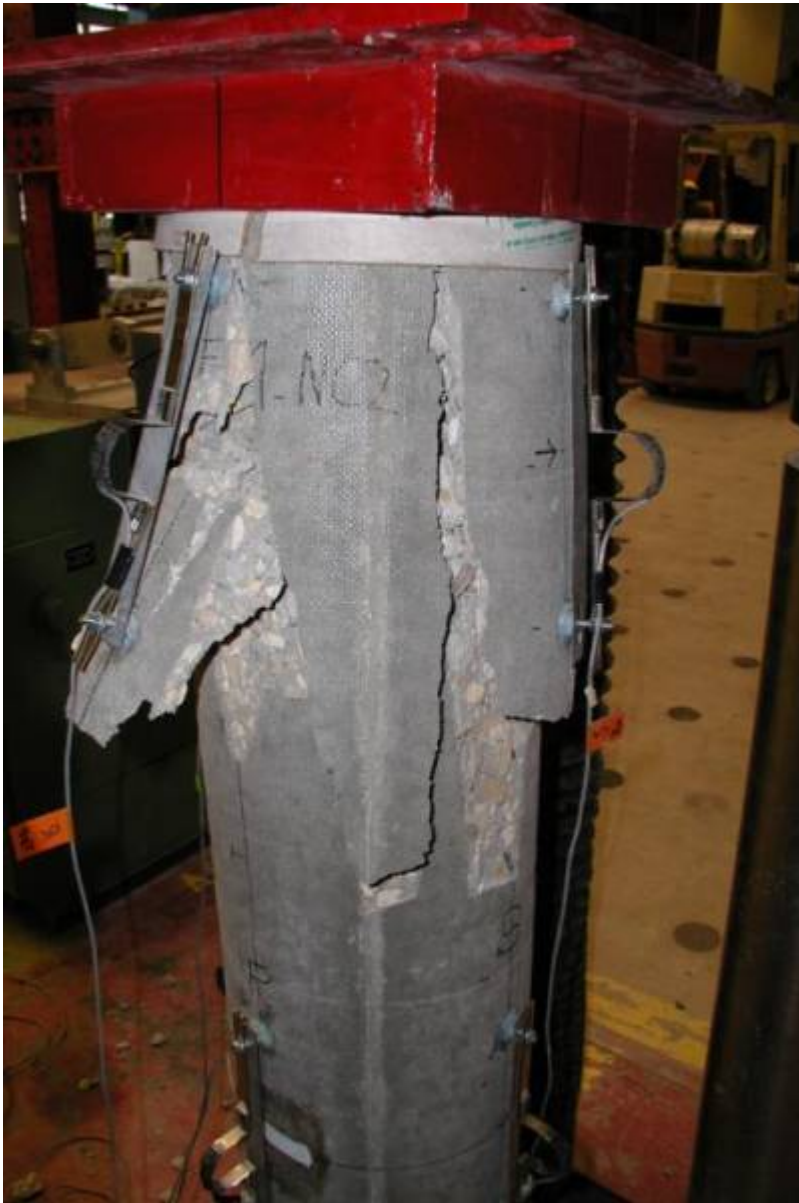
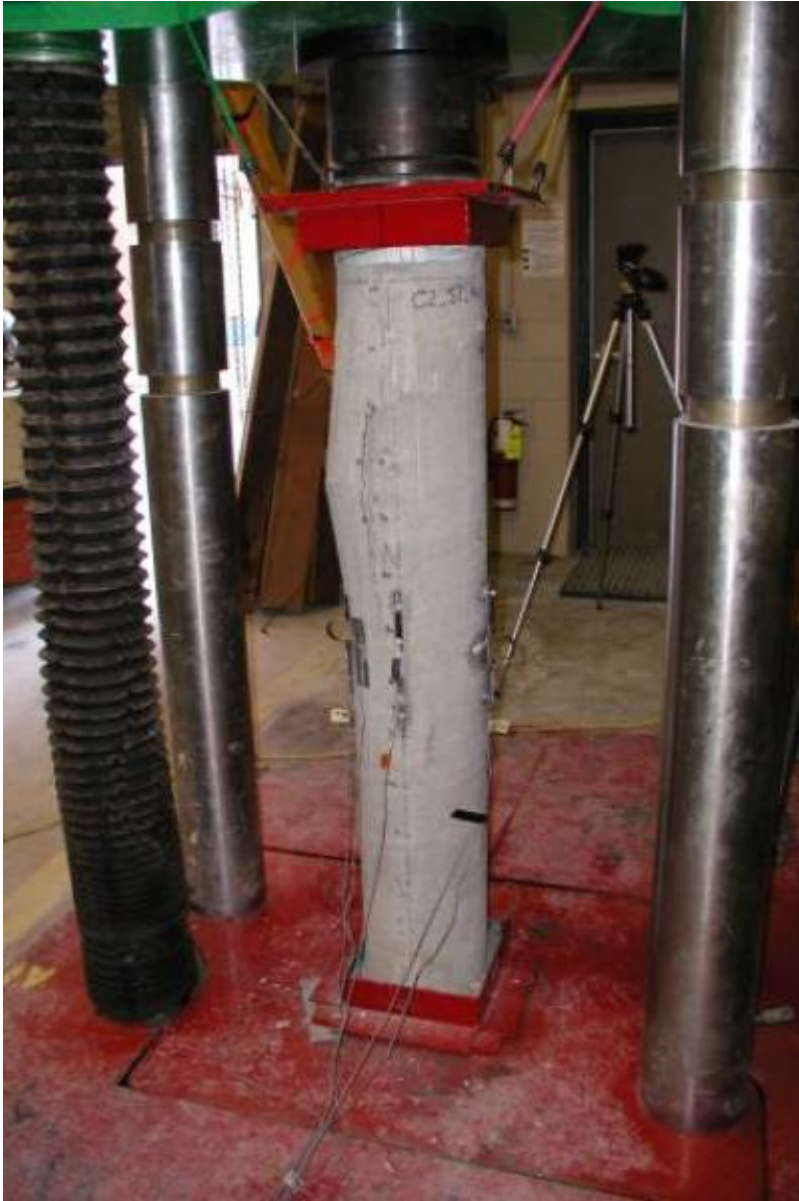
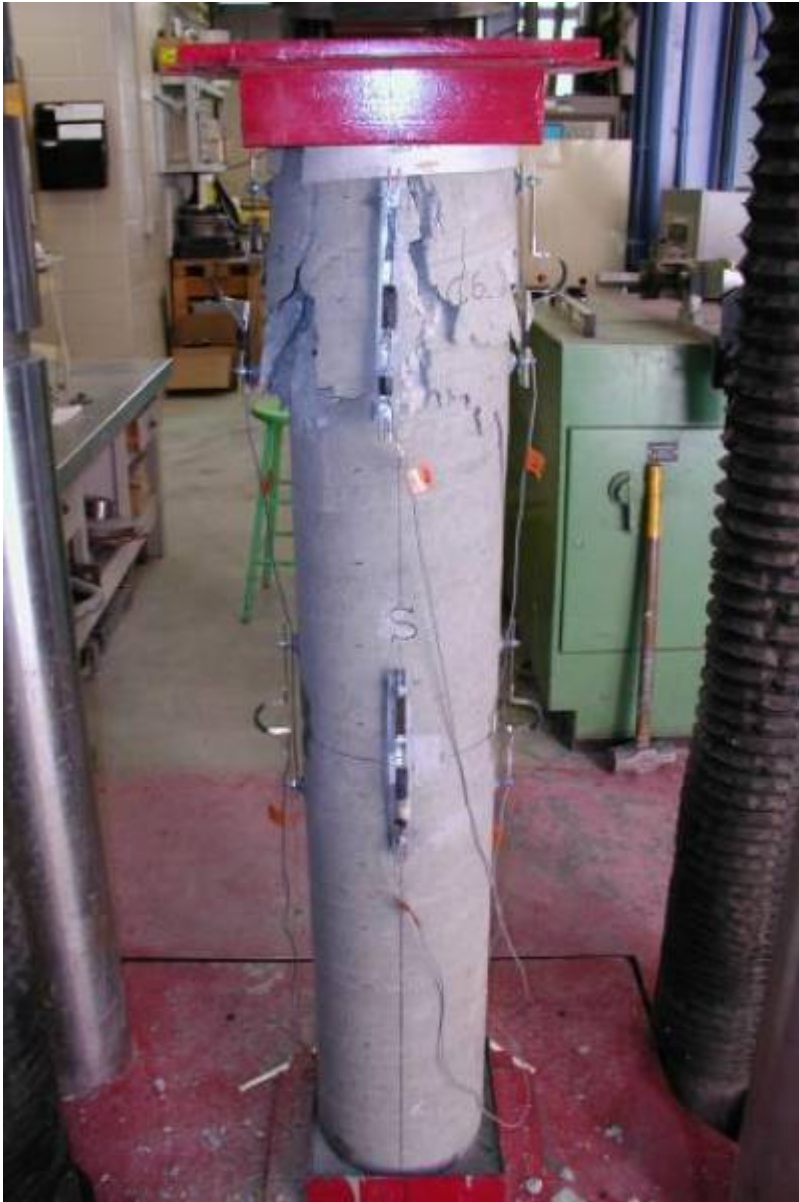
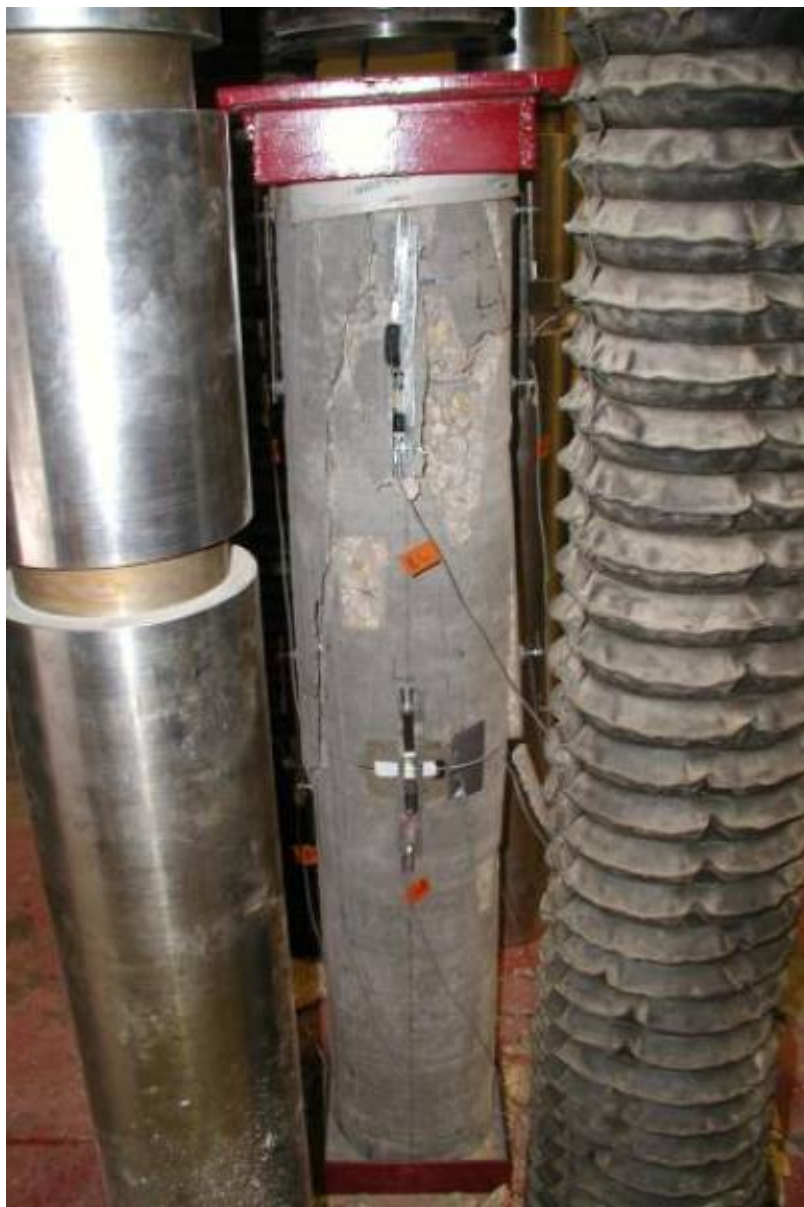
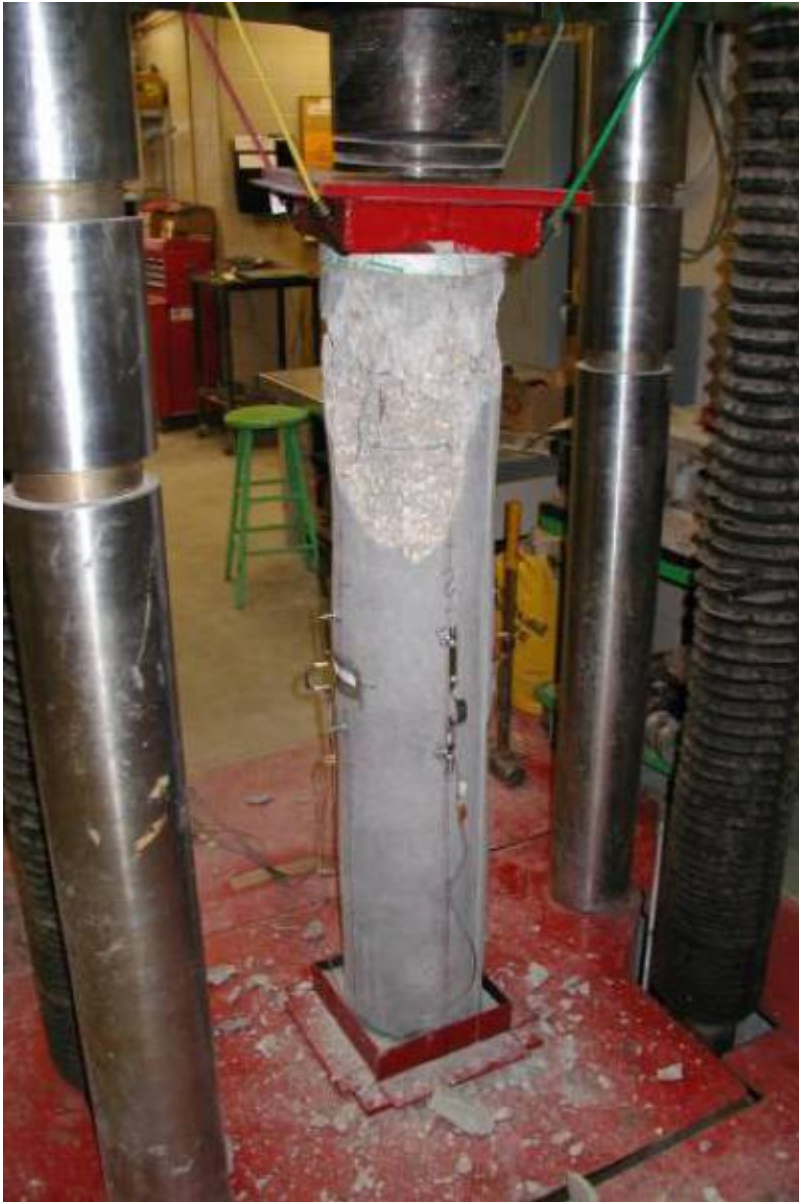
In order to be able to better observe behaviour and the failure pattern of the columns, all tests were videotaped. The failure pattern of the columns was a factor to be investigated in this phase of the study. Based on observations of the two cardboard and two fabric-formed column tested, the failure of the cardboard formed column started with crushing on top and then spalling till failure. Cardboard-formed columns presented a typical gradual failure with no sign of brittleness, no longitudinal cracks and no flaking. On the other hand, fabric-formed columns started with crushing on top and development of longitudinal cracks at the same time along with spalling. Also, some flaking and relative sudden failure of

outside surface was observed. Photographs of these column failures are shown in Figure 65 (page 82).

Flaking and surface concrete delamination observed in the failure of both fabric-formed columns also confirms that the surface of the concrete cast in fabric formwork was more brittle than concrete cast in conventional formwork. The change in Poisson's ratio was also studied when these columns were tested. The value was derived from dividing the average value of the data from two circumferential strain gauges placed at 180° apart from one another, by their corresponding axial pi-gauges. Both flyash and normal concrete fabric formed columns, proved to have lower Poisson's ratio value which is another indication of brittleness and less surface deformation in the fabric-formed specimens. It is necessary to mention that it is nearly impossible to form a perfectly straight column using handmade fabric column formwork, so very small values of eccentricity in loading condition may occur. Since small values of the eccentricity do not create large moment values at end portion of the columns, the effects of small eccentricities can be neglected [2].

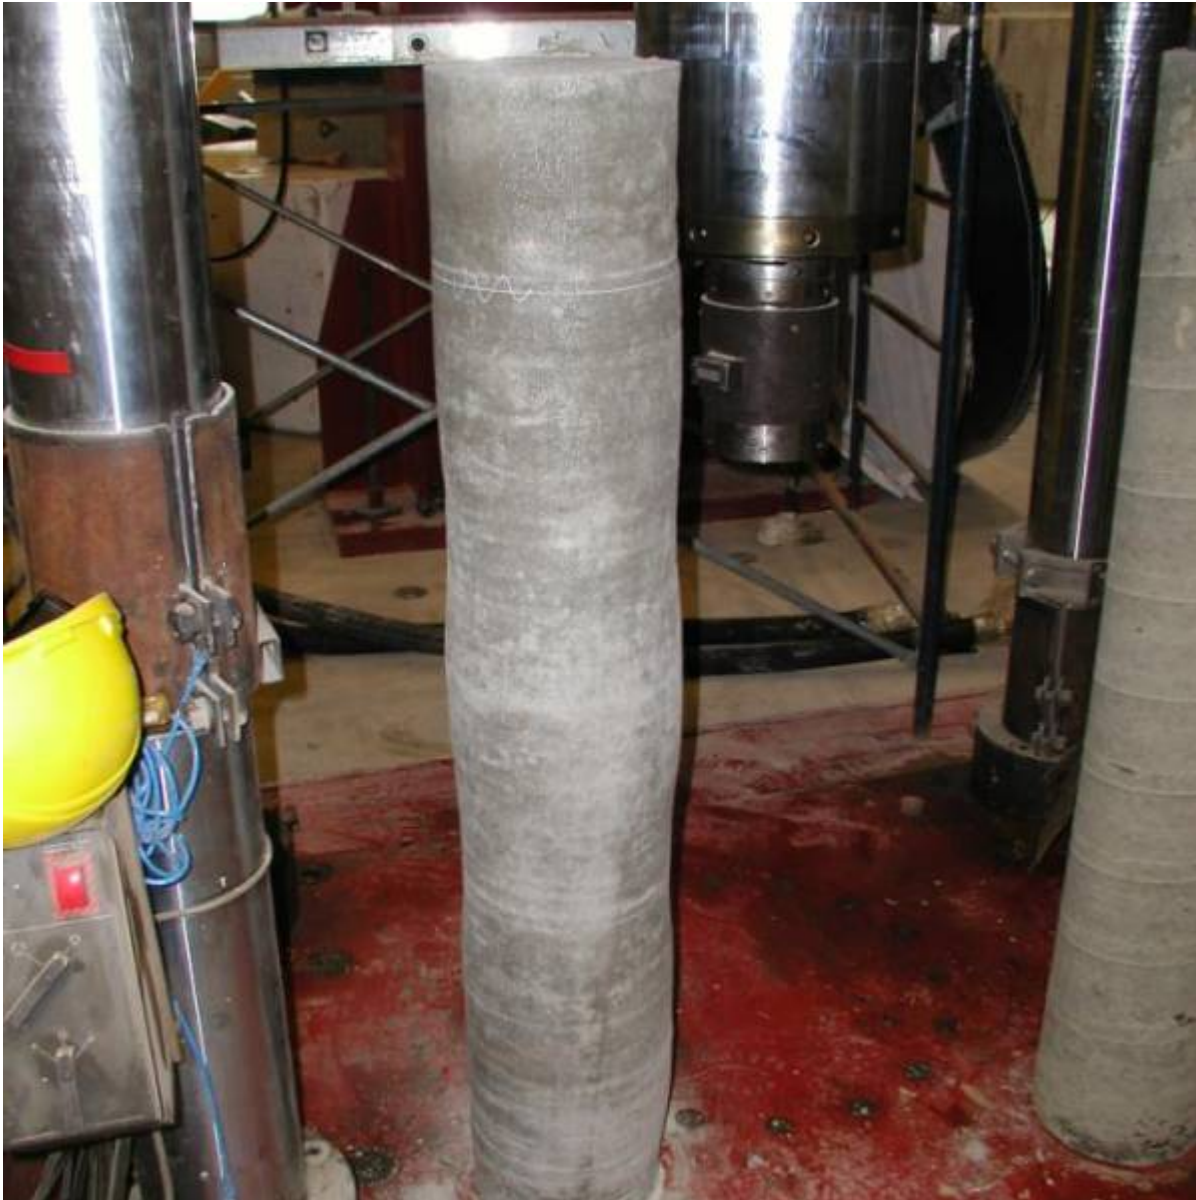
Our first attempt of casting a concrete column using fabric formwork was not quite successful. The column was bulgy at some points and it did not have constant diameter along its length while cardboard molds that are industrially manufactured are perfectly symmetrical tubes and form perfectly symmetrical columns. The reason for this problem was that the fabric was sandwiched between the boards using bolts and when the concrete was poured inside the mold, the hoop tension created by the liquid concrete pulled the fabric out between the bolts (Figure 66). Areas supported by bolts resisted the pressure while parts away from bolts deformed creating bulges along the length of the hardened concrete column, as shown in Figure 67.

Figure 67: Bulged concrete column.

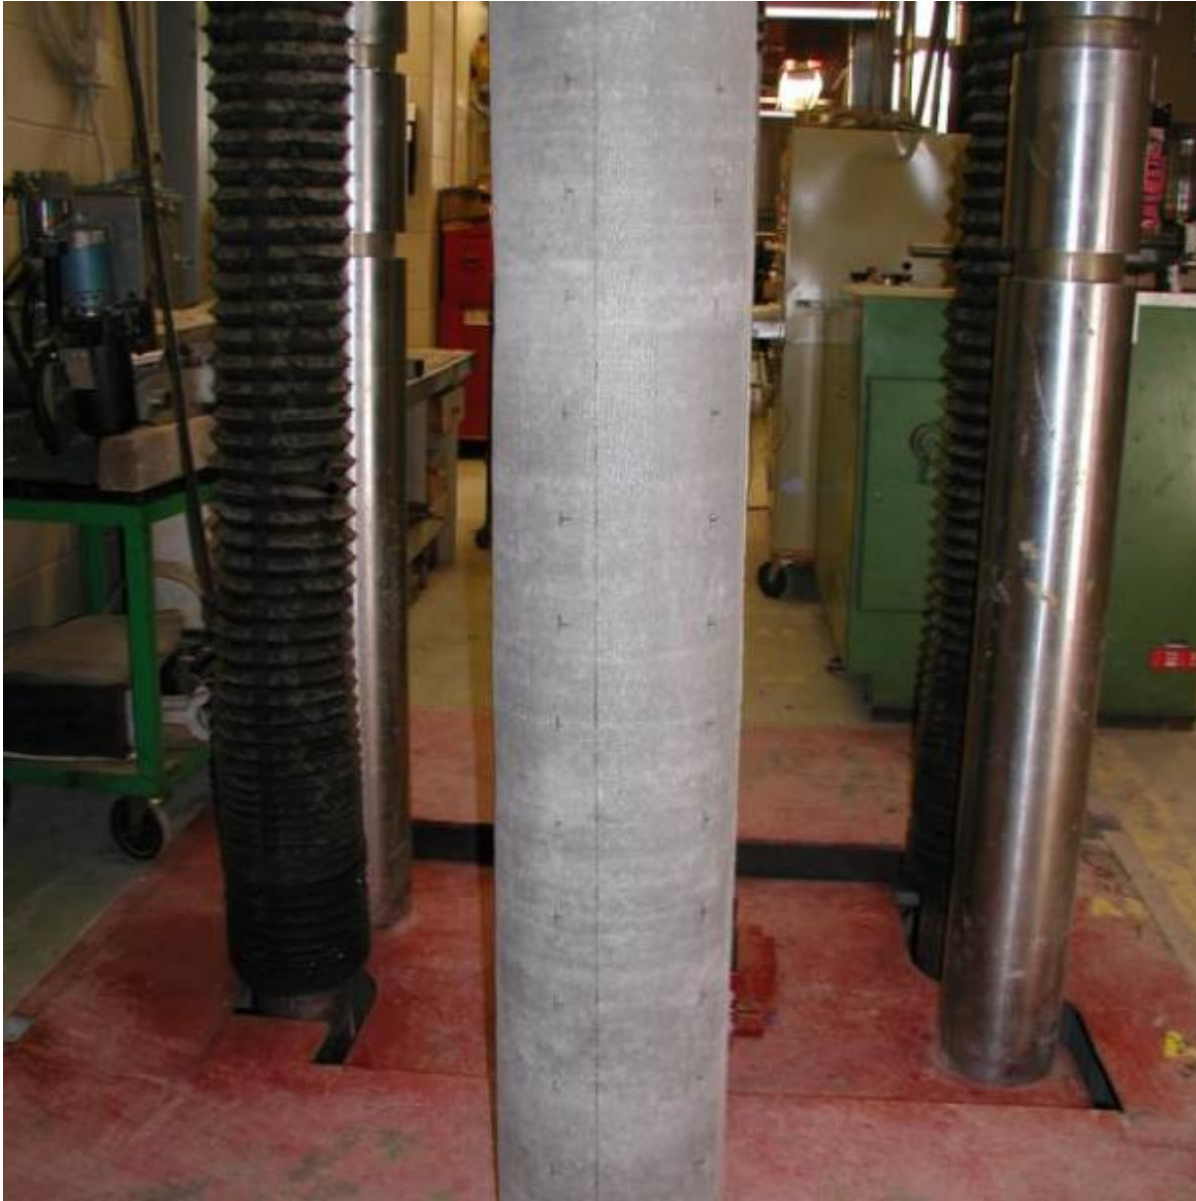
from each other (though less staples would be probably also sufficient), providing a stitch line from top to bottom of the formwork. Orientation of the stitch line can be seen in Figure 43. Stapling provided an even distribution of the hoop forces along the height of the formwork and resulted in a uniform cylindrical geometry. The variation in diameter of the column along its length was dramatically reduced as demonstrated in Figure 68.

Figure 68: Modified fabric formwork resulting in a straight column.
